FINAL REPORT:
SKINNERVILLE-GREENVILLE HEIGHTS HISTORIC DISTRICT &
PERKINS TOWN-CHERRY VIEW POTENTIAL HISTORIC DISTRICT
RESURVEYS

PREPARED BY:
HEATHER M. SLANE & SUNNY STEWART

FOR:
THE CITY OF GREENVILLE, NORTH CAROLINA
JULY 2014

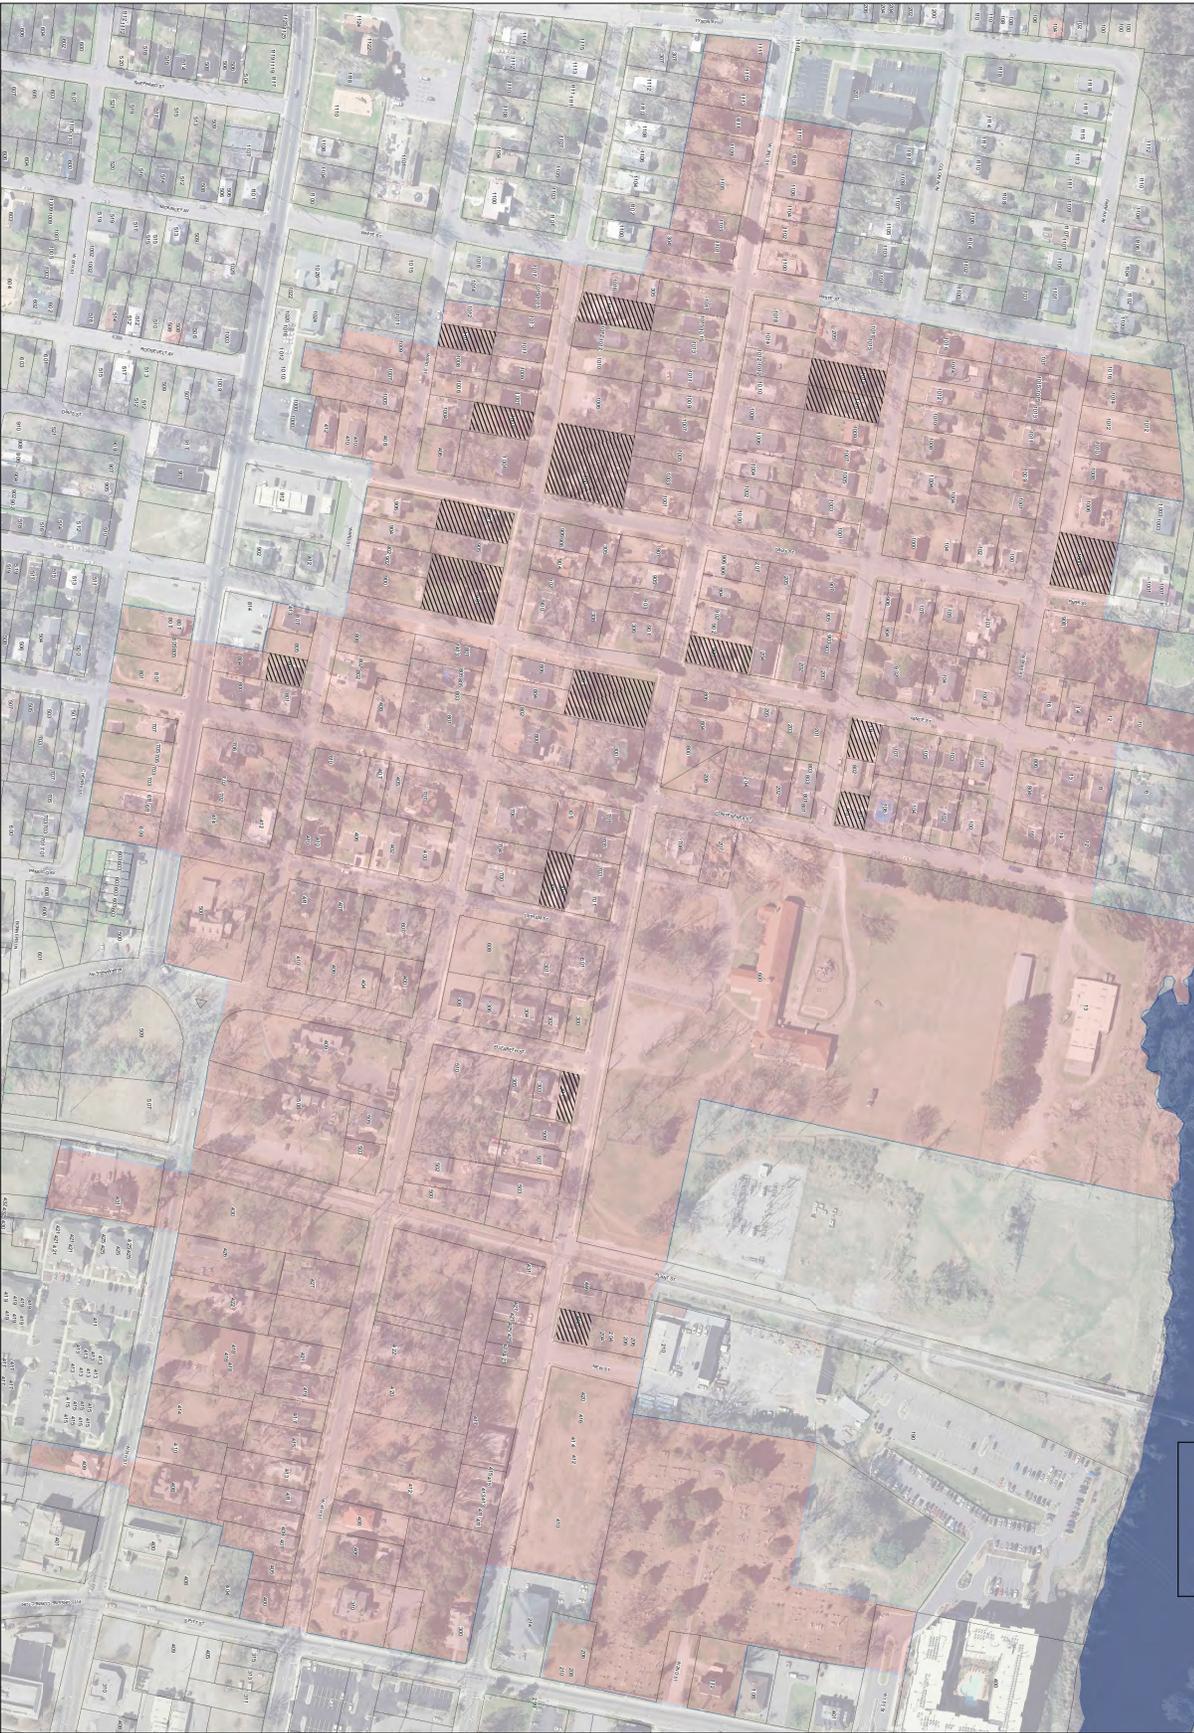
DETERIORATED OR BOARDED PROPERTIES

The re-evaluation revealed the seventeen [17] contributing primary resources, 6 percent of the total primary resources, within the district boundary are significantly deteriorated or are unoccupied and have been boarded. It is important, however, to note that the majority of resources that have been boarded are in stable condition and not significantly deteriorated. These primary resources are listed in the following table along with a brief notation about their status.

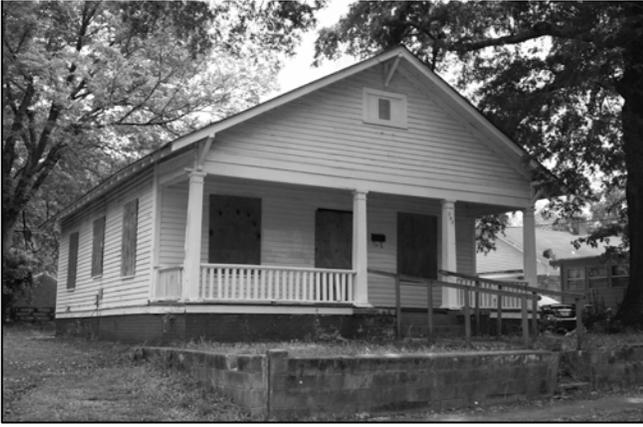
Photo 1: 307 Vance Street – typical boarded property

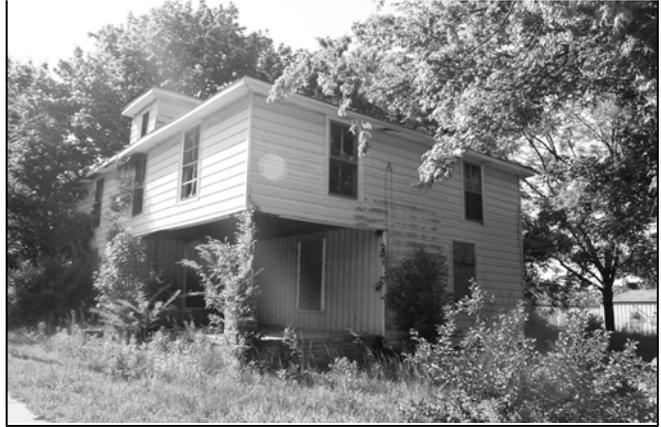
Photo 2: 442 W. Third Street – property with extensive deterioration

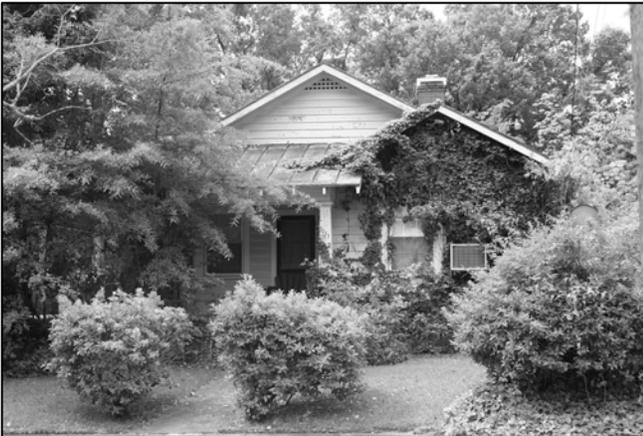
Photo 3: 1011 Colonial Avenue – overgrown but occupied property

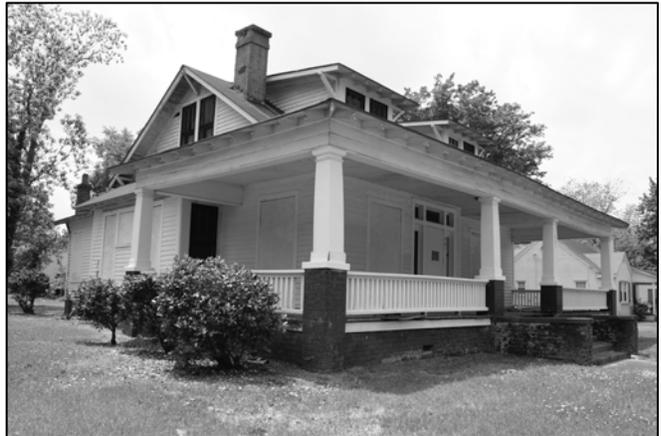
Photo 4: 901 W. Fourth Street – typical boarded property

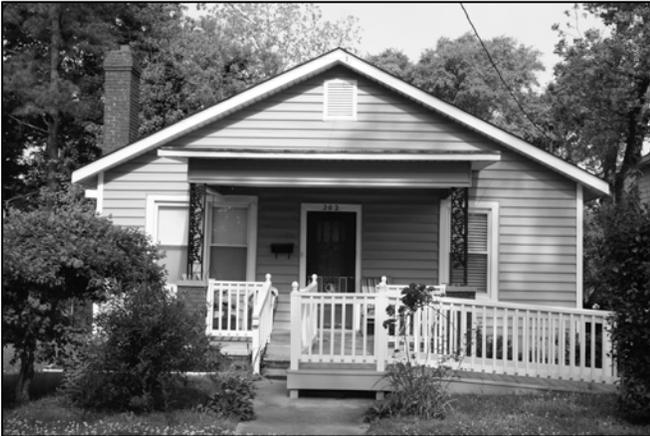
Photo 6: 202 Contentnea Street – property with ramp added to front

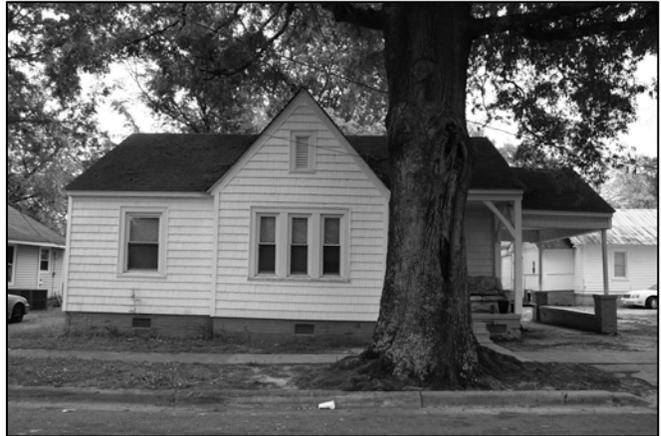
Photo 7: 207 Davis Street – property with vinyl shingle siding and vinyl windows

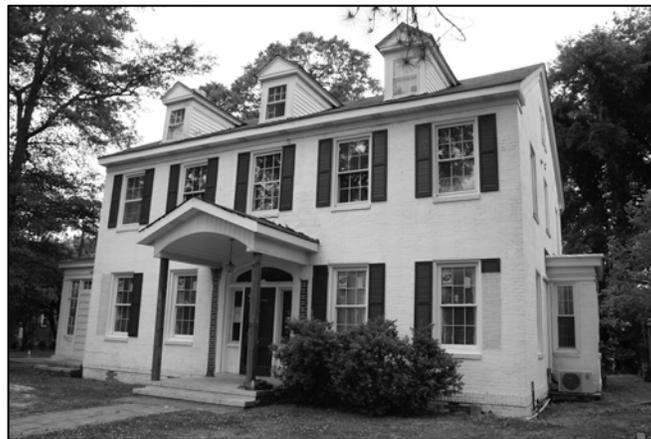
Photo 8: 410 Elizabeth Street – property with vinyl windows and replacement porch posts

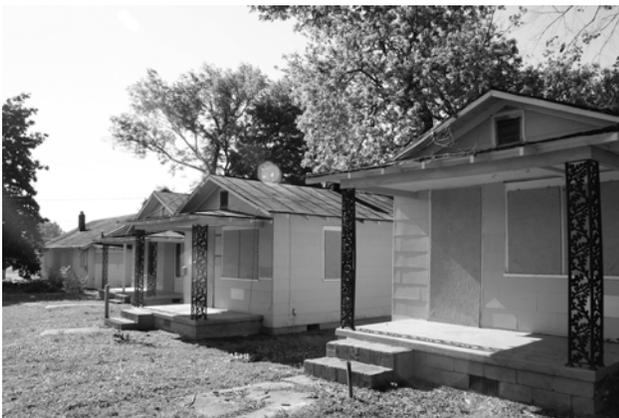
Photo 9: 705-709 Carolina Avenue – typical boarded & vacant properties

Identical to the neighboring house at 707 Carolina, this one-story, front-gabled house is two bays wide and triple-pile. It has a brick pier foundation with concrete-block curtain wall, asbestos siding, and a standing-seam metal roof with exposed rafter tails. It has an interior brick chimney and an exterior brick chimney at the right rear (southwest). Door and window openings have been boarded, but a louvered vent remains exposed in the front gable. The hip-roofed porch is two bays wide and is supported by decorative metal posts on a concrete floor. County tax records date the building to 1925 and Sanborn maps confirm its existence by 1929.

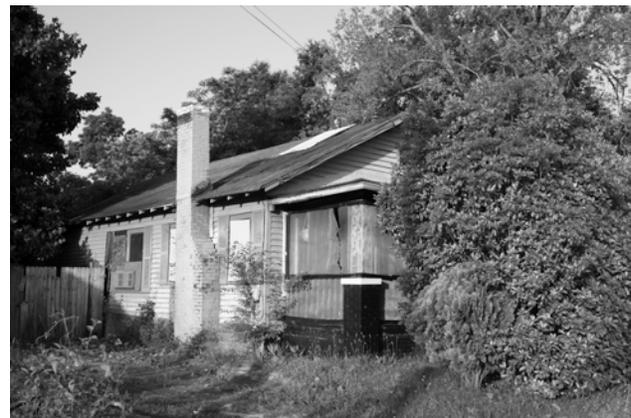
Photo 10: 905 Cherry Street - boarded & overgrown property

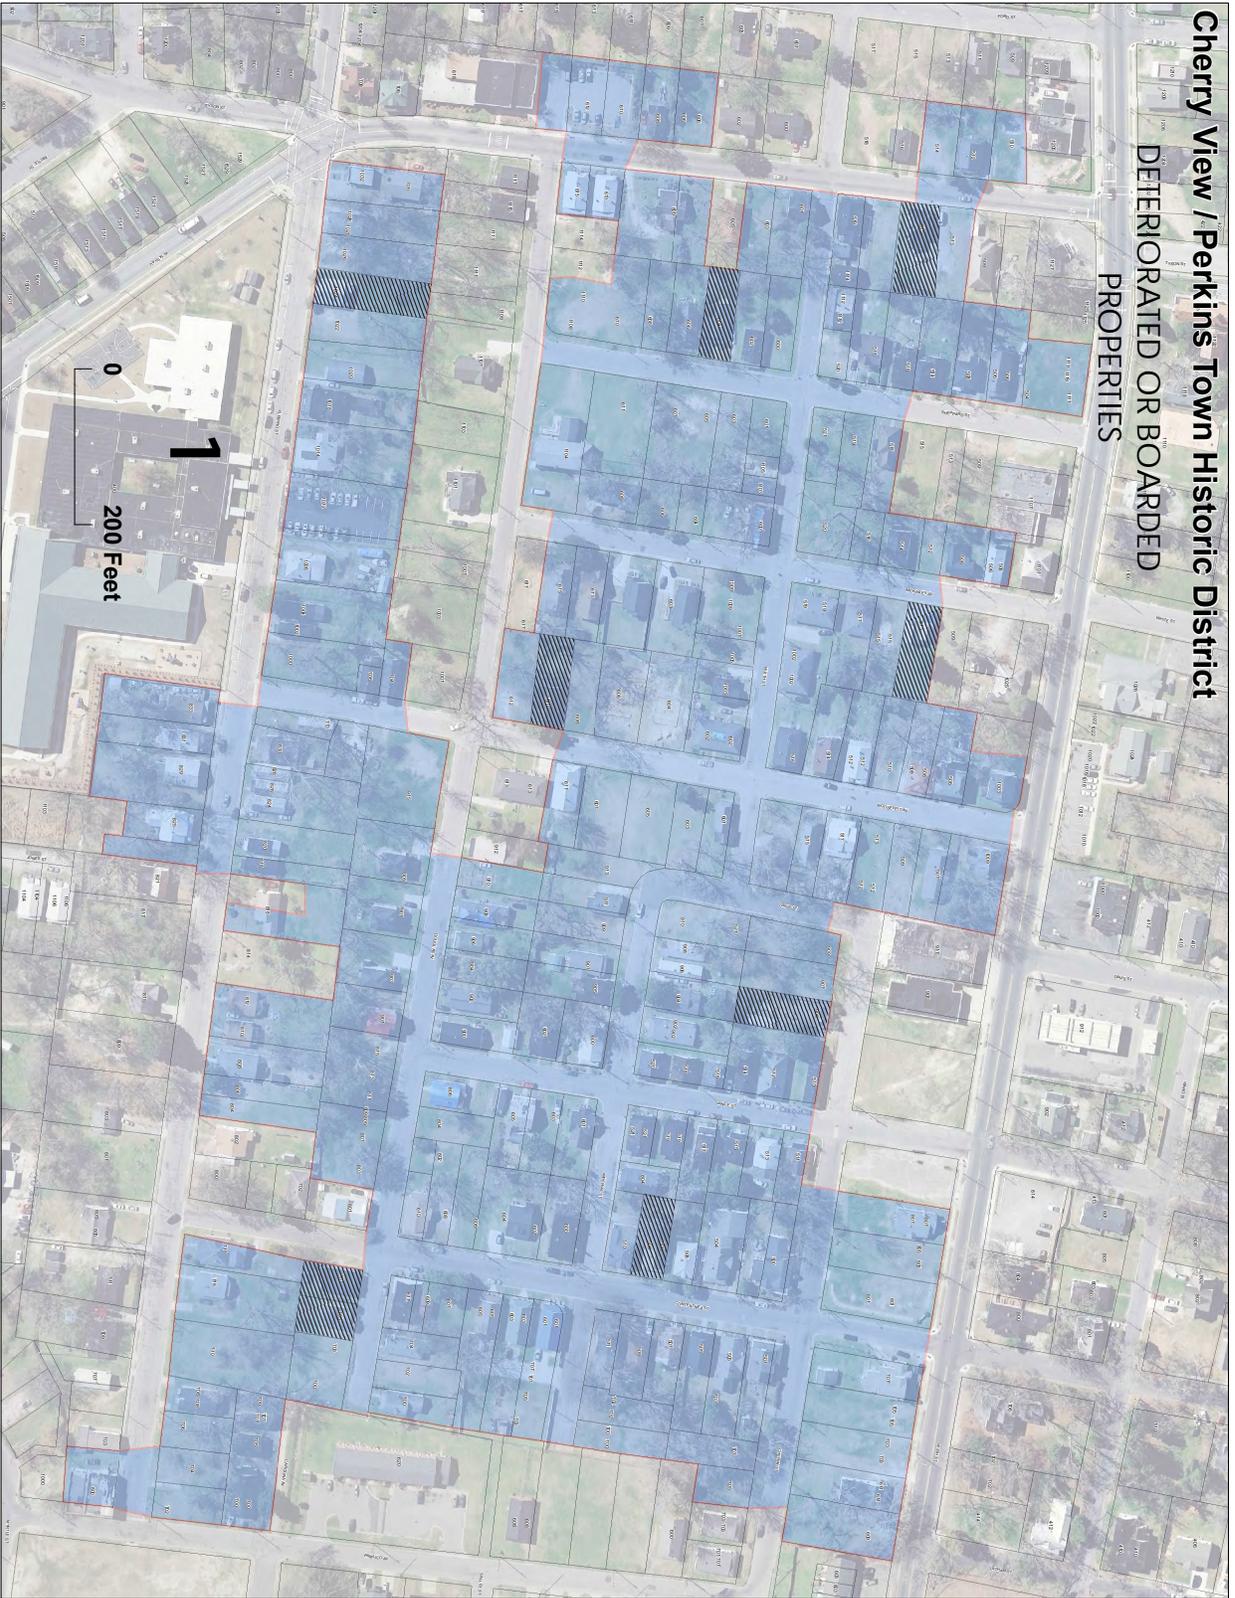
DETERIORATED OR BOARDED PROPERTIES

The re-evaluation revealed the ten [10] primary resources within the study area are significantly deteriorated or are unoccupied and have been boarded. However, it is important to note that the majority of resources that have been boarded are in stable condition and not significantly deteriorated. These primary resources are listed in the following table along with a brief notation about their status (see map, page 20).

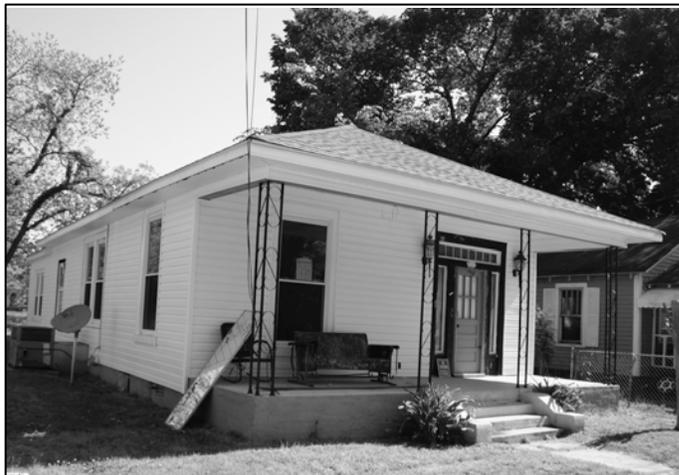
Photo 13: 908 Douglas Avenue – typical property altered with vinyl siding and windows

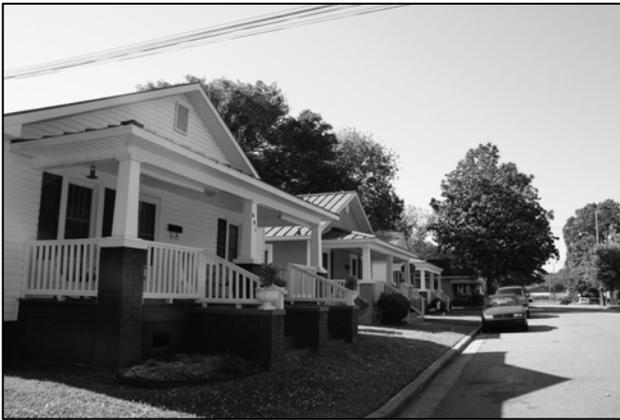
Photo 14: 601-605 Contentnea Street – typical rehabilitated houses with vinyl windows and new metal roofs

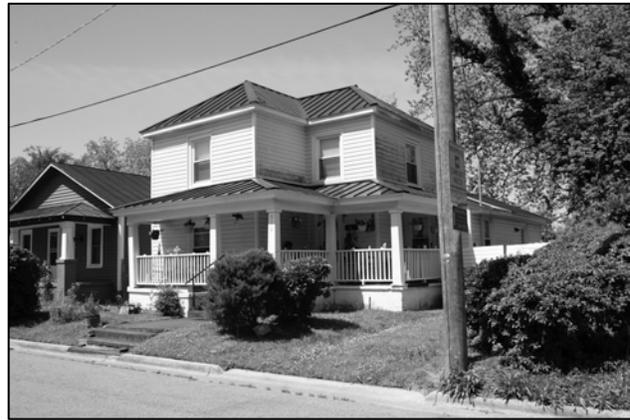
Photo 15: 514 Sheppard Street – typical rehabilitated house with vinyl windows and new metal roofs
