Interested firms are invited to submit proposals (in the required quantity, format, and with the required forms included in the RFQ) for the **“City of Greenville- Town Common Bulkhead and Esplanade Project”** by **2:00 pm, Tuesday, August 2, 2022** to the following address:

**Structural Condition  
Assessment of Bulkhead**  
Town Common Park | Greenville, NC  
Produced for The East Group

<b>Client</b>	The East Group
<b>Project name</b>	Town Common Park   Greenville NC
<b>Document title</b>	Structural Condition Assessment of Bulkhead
<b>Status</b>	Final Report
<b>Date</b>	June 1, 2022
<b>Project number</b>	220606
<b>File reference</b>

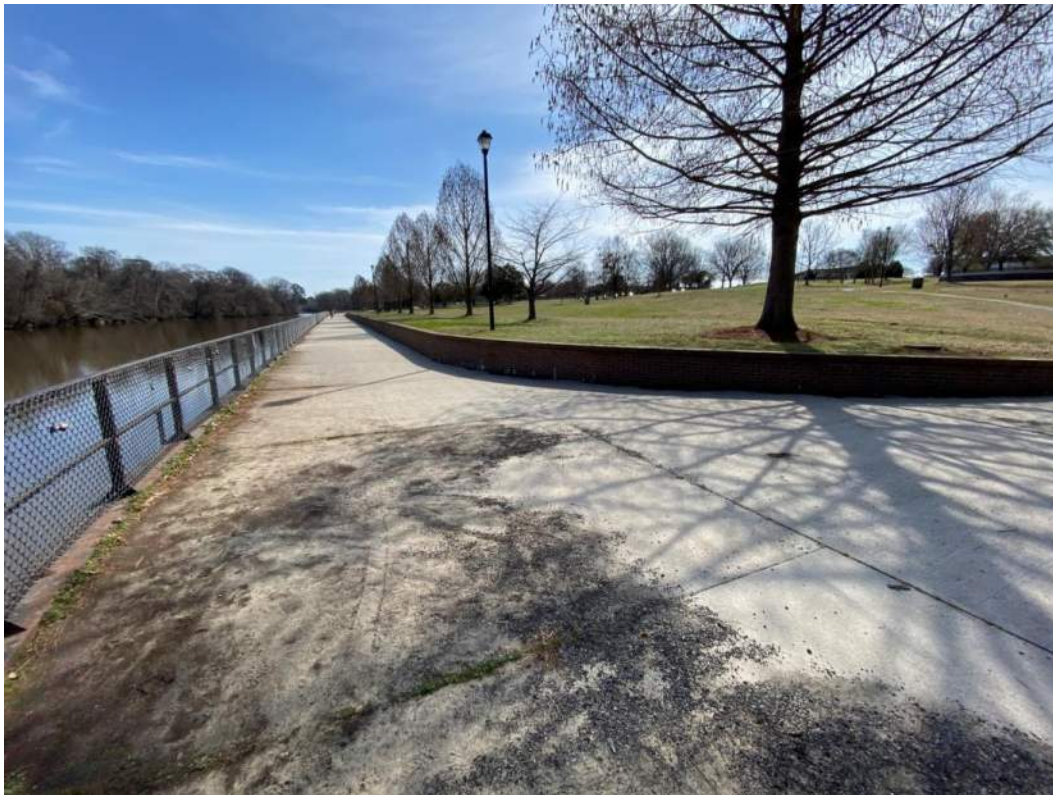
The steel sheet pile bulkhead runs east-west and serves to delineate the Town Common esplanade and amphitheater park on the south bank of the Tar River. The anchored bulkhead is approximately 1,570-feet long and consists of MP-116 steel sheet piles. The top of the bulkhead is at elevation (EL) +15 with the tips of the sheet piles at EL -17. The design riverbed depth is EL -5. Behind the bulkhead is a 6-inch thick concrete slab-on-grade sidewalk that extends back 15-feet to a 9½-inch thick by 3-feet high brick retaining wall. The brick wall retains fill for the grass park area that is located behind it. See Figure 2 in Appendix A and Photograph 2.1 below for a typical elevation of the bulkhead and esplanade. It should be noted that the stationing used in this report and during the inspection is based on linear feet of bulkhead, starting at the southeast corner.

**PHOTOGRAPH 2.1: VIEW OF ESPLANADE LOOKING EAST**

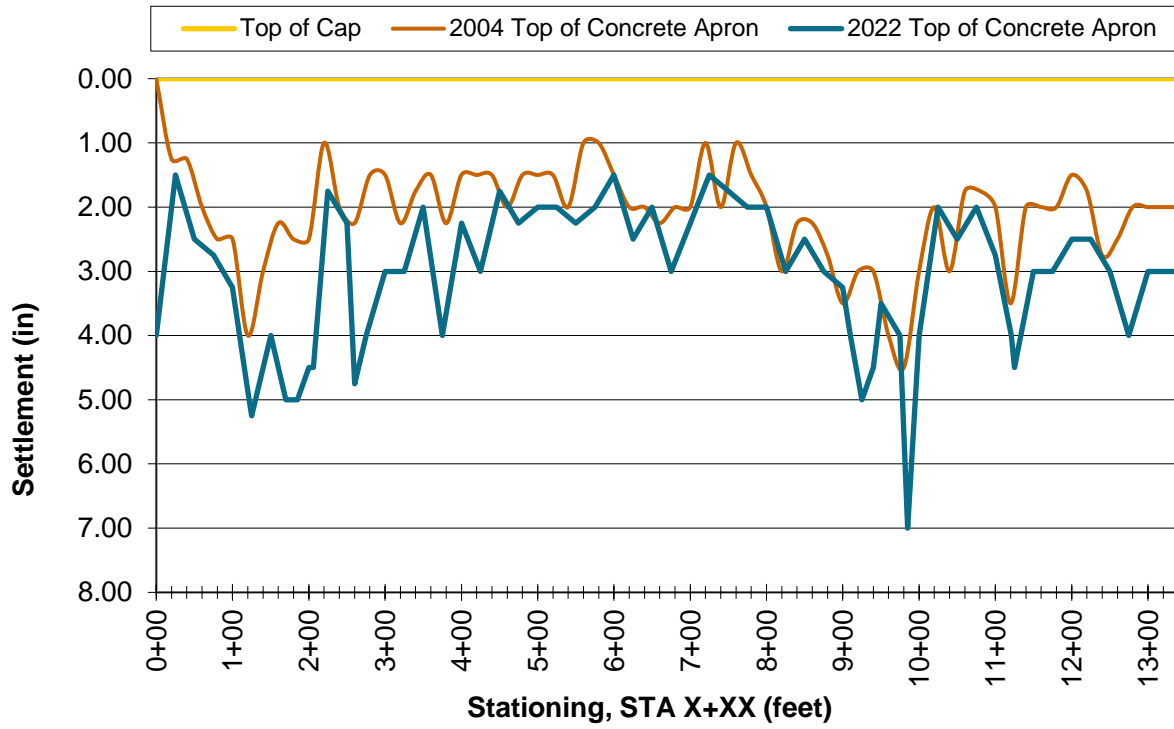
The concrete sidewalk is in satisfactory condition, with minor to no cracking and very minor spalling of concrete around the joints. The sidewalk has experienced between 2-inches to 7-inches of settlement, as can be seen in Graph 2.1 and Photograph 2.2 below. Graph 2.1 shows the height difference between the top of the slab and the top of the steel sheet pile cap with a comparison to the height difference measured in 2004. The concrete sidewalk has generally settled an additional 1-inch compared to 2004. This is not necessarily indicative of the void depth below the slab but does identify possible overall settlement or loss of fill behind the bulkhead. For instance, at Station 1+85, the top of the concrete sidewalk was approximately 5" below the sheet pile cap. At this location, it was possible to measure a gap behind the concrete and a void was measured to 16" below the sheet pile cap.

GRAPH 2.1: CONCRETE SLAB SETTLEMENT AT BULKHEAD CAP

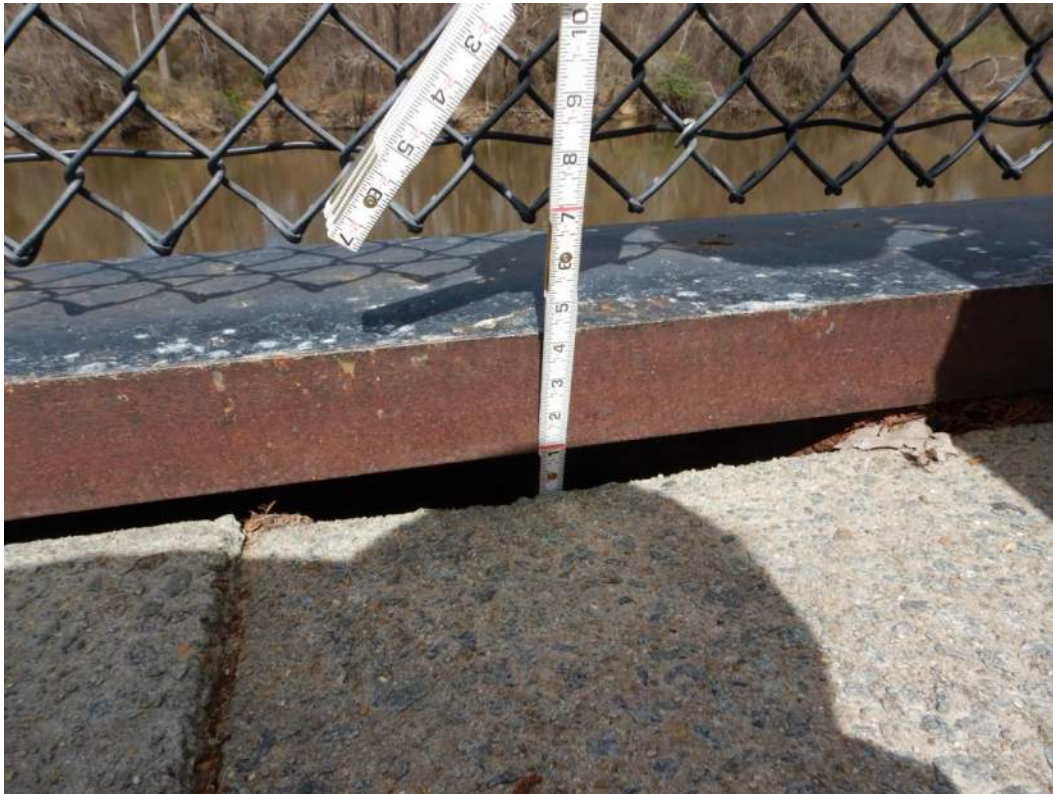
PHOTOGRAPH 2.2: SETTLEMENT OF SLAB AT EDGE OF BULKHEAD CAP (STATION 1+85)

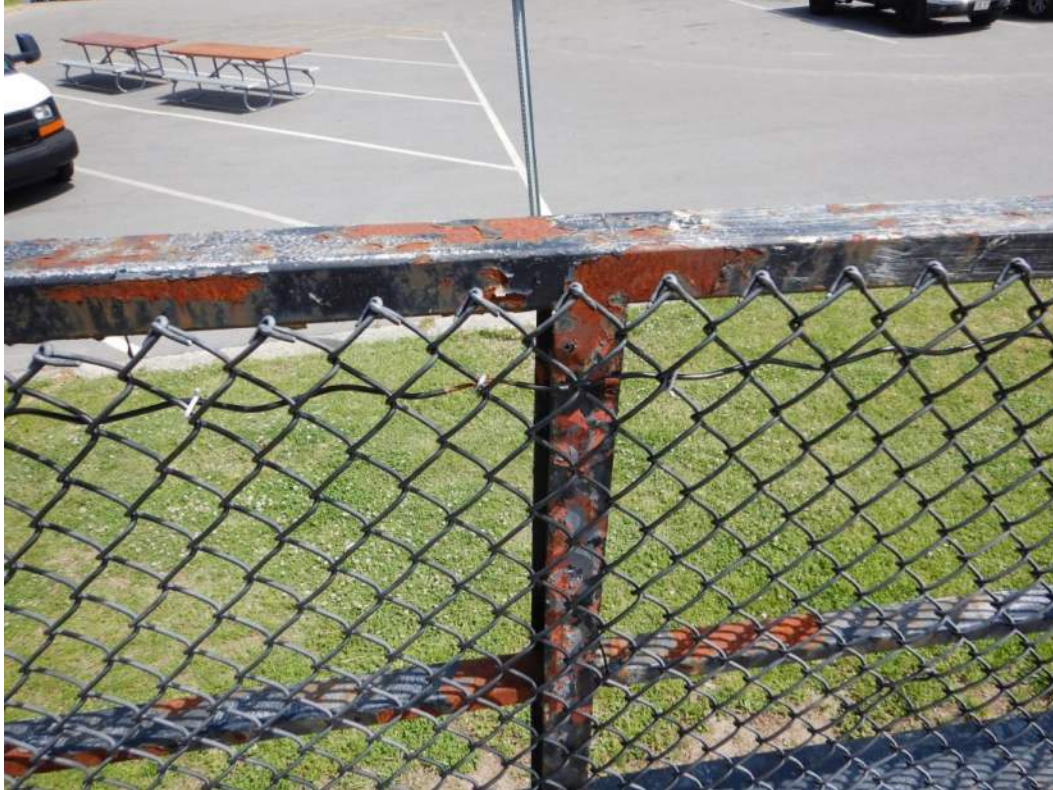
The handrail along the top of sheet pile bulkhead is in satisfactory condition. The majority of the posts and rails are structurally sound, but the coating is in poor condition. The coating is peeling off and the metal underneath is lightly corroded as shown in Photograph 2.3 below. The PVC coated chain link mesh is in good condition, with very little corrosion. The two triangular gusset plates located on the first post at Station 0+02 are heavily corroded, with severe loss of section. It also appears that in this area the cap or handrail was impacted by some type of equipment or vehicle, as shown by the gap between the cap and gusset in Photograph 2.4 below. Overall, the steel channel cap is in good condition, but the paint is starting to peel in isolated areas and the underlying steel is corroding.

**PHOTOGRAPH 2.3: TYPICAL CONDITION OF EXISTING HANDRAIL**

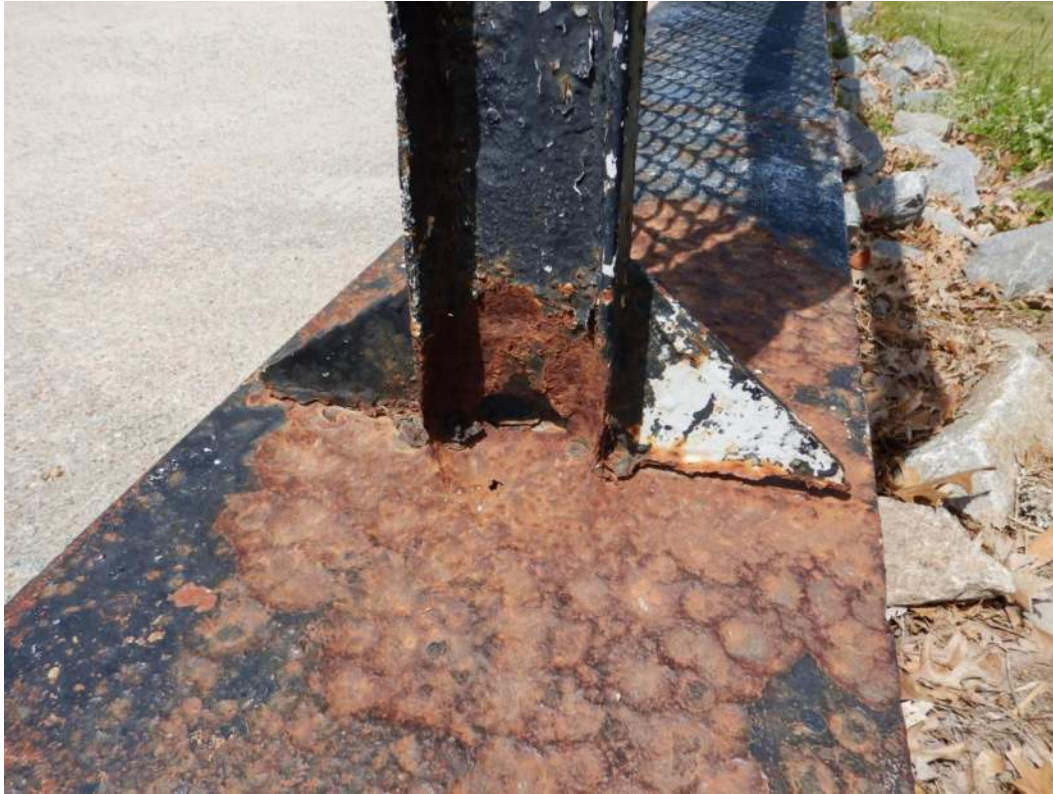
**PHOTOGRAPH 2.4: CONDITION OF FIRST HANDRAIL POST (STATION 0+02)**

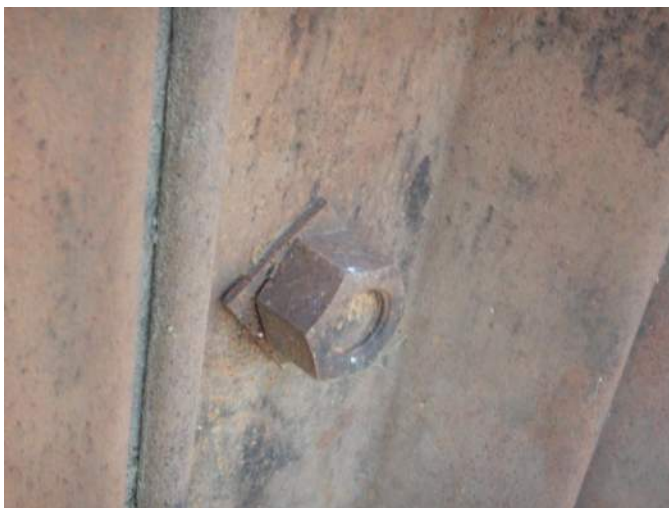
The sheet piles are lightly corroded from the top down to approximately EL +7. From EL +7 down to the riverbed, the sheet piles are moderately to heavily pitted with moderate organic growth. The tie rods and wale anchor bolts are lightly corroded with one 1-inch diameter bolt missing at Station 1+78. In addition, many of the nuts for the tie rods are not completely threaded onto the rod. The end of the rod is approximately 1/2 inch from the outside face of the nut, see Photograph 2.5 below for a typical example.

**PHOTOGRAPH 2.5: TIE ROD NUT**

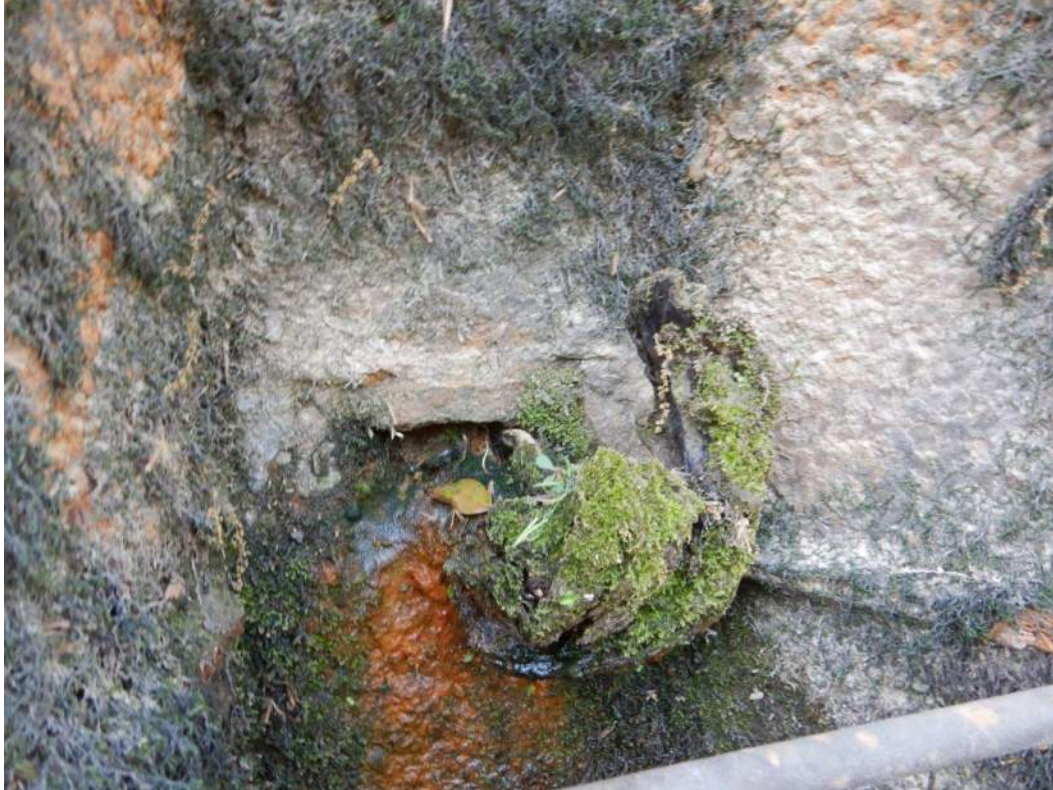
Another significant deficiency in the existing bulkhead is the poor condition of the weep holes and outfall penetrations. The angles that hold the cinder paving bricks over the weep holes are either severely corroded or have completely deteriorated and fallen off the sheet piles as shown in Photograph 2.6 below. Subsequently, the bricks are either missing or not fully covering the holes. This allows the finer backfill material to flow out from behind the bulkhead, creating sinkholes in the backfill and settlement of the concrete slab above. Since the inspection in 2004, vegetation growing through the existing weep holes have greatly increased in size causing some ladders to be unusable. See Photograph 2.7 below for a comparison of tree/vegetation size between 2004 and 2022.

**PHOTOGRAPH 2.6: TYPICAL CONDITION OF SHEET PILE WEEP HOLES**

Potential repairs to address the noted deficiencies in the bulkhead could be developed, such as strengthening the steel sheet pile, providing new weep holes, and filling voids behind the bulkhead. However, any potential repairs are anticipated to be cost prohibitive and are not recommended.

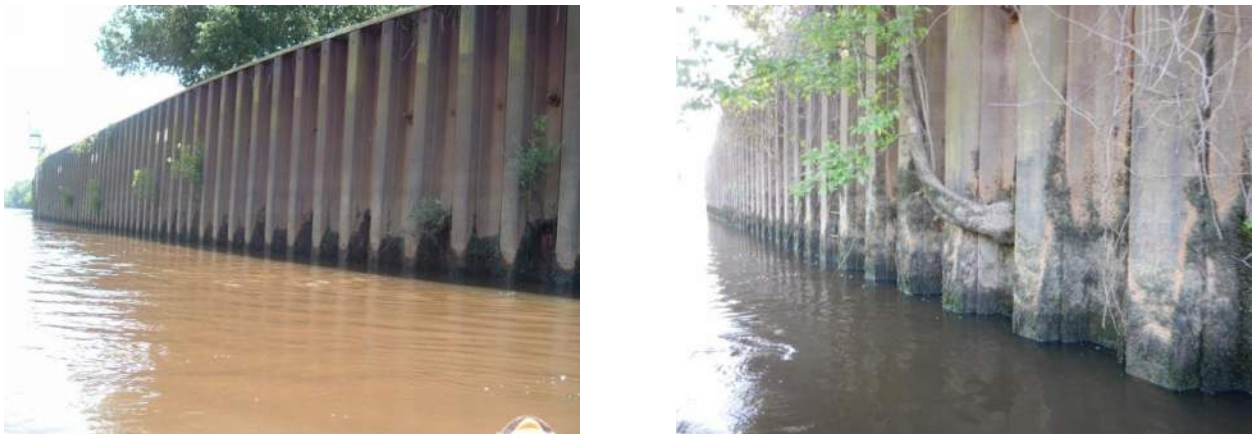
**PHOTOGRAPH 2.7: VEGETATION GROWTH BETWEEN 2004 (LEFT) AND 2022 (RIGHT)**

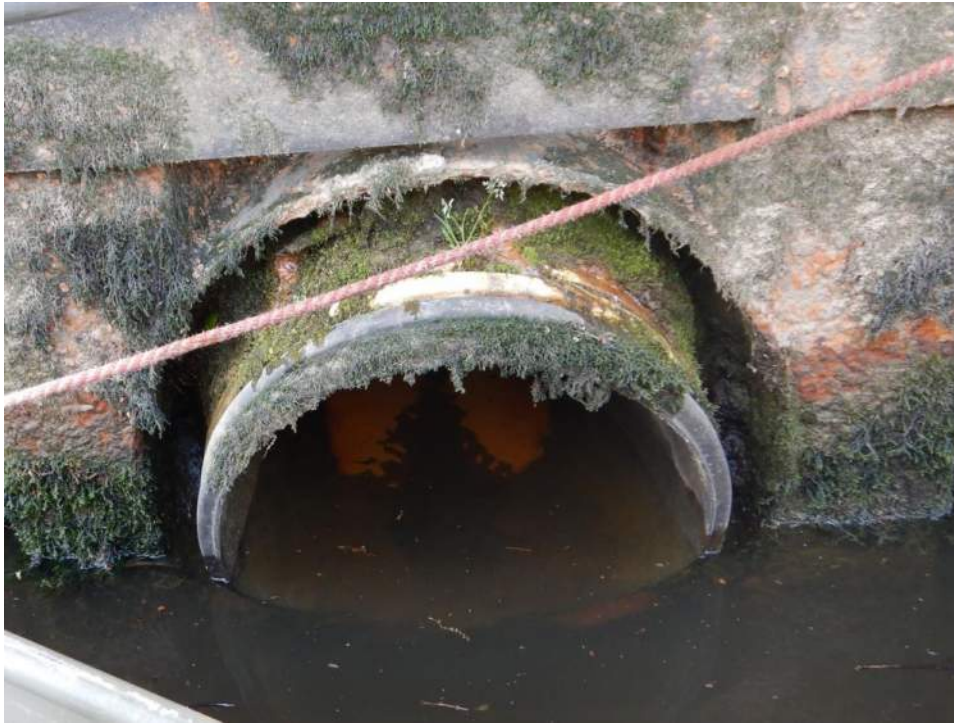
In addition to the weep holes, a similar problem is occurring at the outfall penetrations. The packing material that sealed the joint between the pipe sleeve and the CMP outfall has deteriorated. The gap is approximately two to three inches, which allows some of the larger backfill material to flow out from behind the bulkhead. Photograph 2.8 below shows the gap between the CMP outfall and the steel pipe sleeve at Station 10+38. In addition, it appears that the CMP outfall may have had a partial collapse approximately 10-feet back from the face of the bulkhead. There are sections of the CMP pipe and a buildup of sand lying on the bottom of the pipe. The outfall at Station 4+18 has been lined with a 20-inch diameter HDPE pipe, probably due to holes that formed in the existing CMP outfall. The annulus between the HDPE pipe and steel pipe sleeve was not filled with grout; therefore, there is a small gap that is allowing fill to flow out. Photograph 2.9 below shows the condition at this outfall location.

**PHOTOGRAPH 2.8: CONDITION OF CMP OUTFALL AND STEEL PIPE SLEEVE (STATION 10+38)**

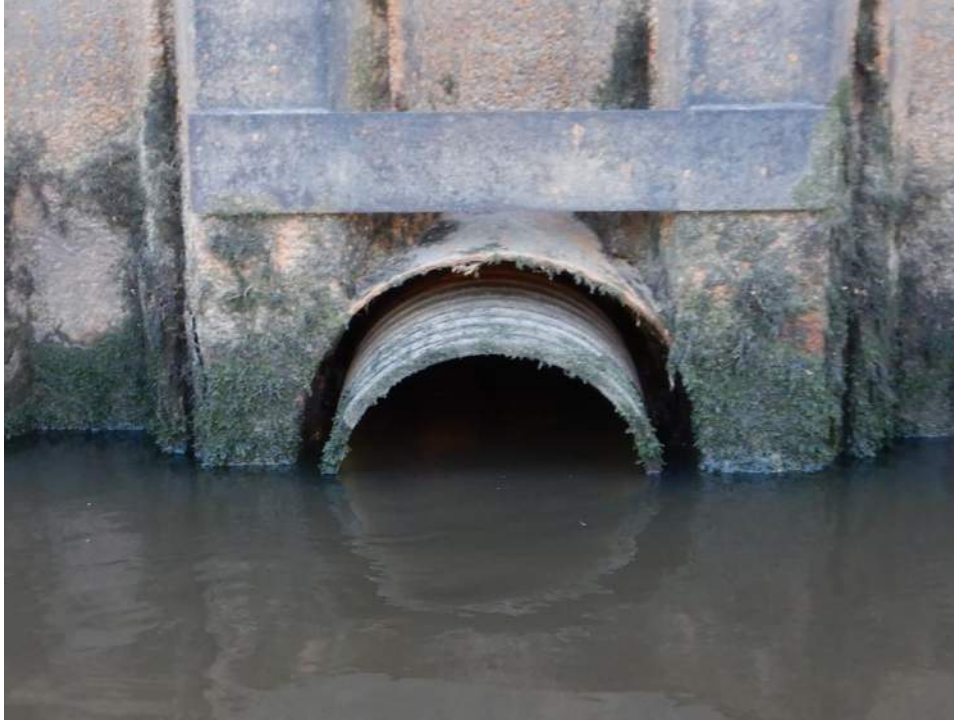
**PHOTOGRAPH 2.9: CONDITION OF CMP OUTFALL AND STEEL PIPE SLEEVE (STATION 4+18)**

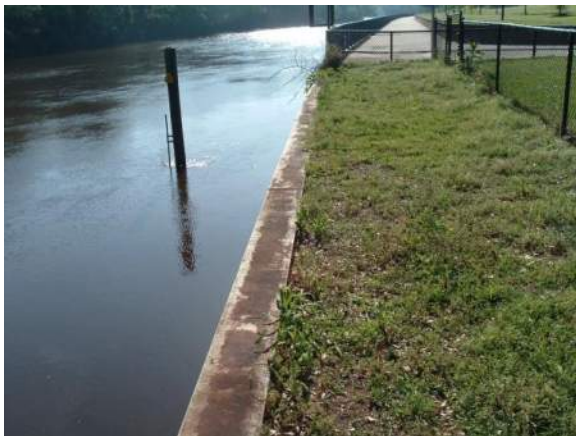
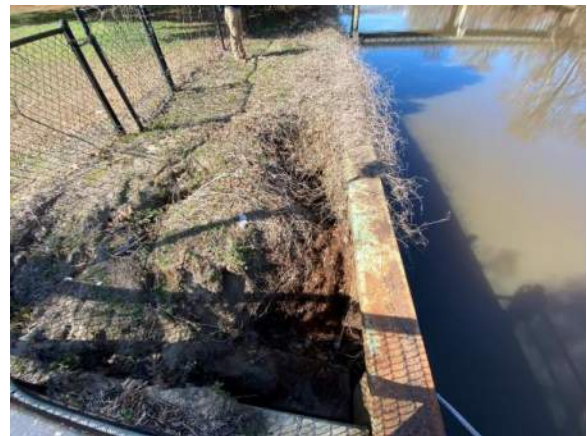
In the grass area from Station 13+66 to the end, sinkholes have formed behind the bulkhead, which are located directly above an open weep hole in the concrete. The largest of the sinkholes is located at Station 13+66 and is 12-feet wide by 4-feet deep and is undermining the adjacent concrete sidewalk. Photograph 2.10 below shows a comparison of how the sink holes have changed in size between 2004 and 2022.

**PHOTOGRAPH 2.10: SETTLEMENT AT STATION 13+66 BETWEEN 2004 (LEFT) AND 2022 (RIGHT)**

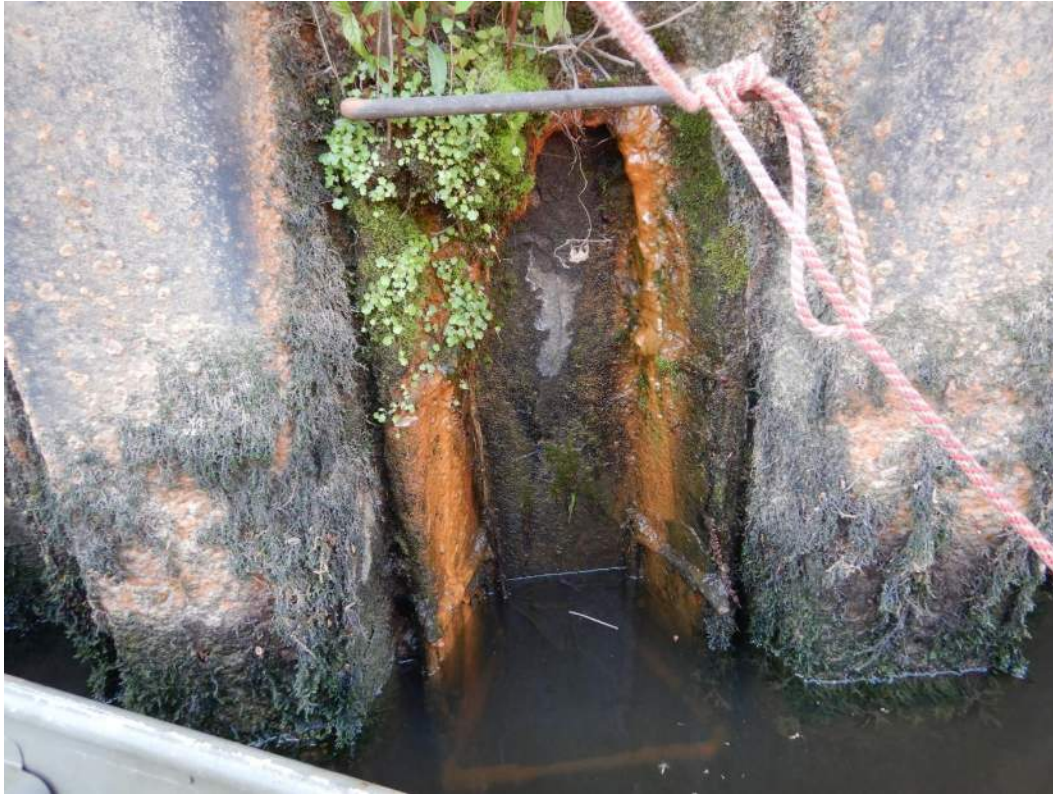
The steel access ladders are in fair condition, with minor corrosion between EL +4 to EL +15 and moderate to heavy corrosion below EL +4. The bottom 3 to 4 rungs have heavier corrosion due to their proximity relative to the water level. The bottom four rungs at Stations 4+60, 5+56, 6+20, 6+52, 11+01, 11+32, 11+65, and 11+98 are severely corroded and have experienced significant loss of section with some rungs missing, as shown in Photograph 2.11 below.

**PHOTOGRAPH 2.11: MISSING BOTTOM RUNGS OF AN ACCESS LADDER (STATION 11+65)**

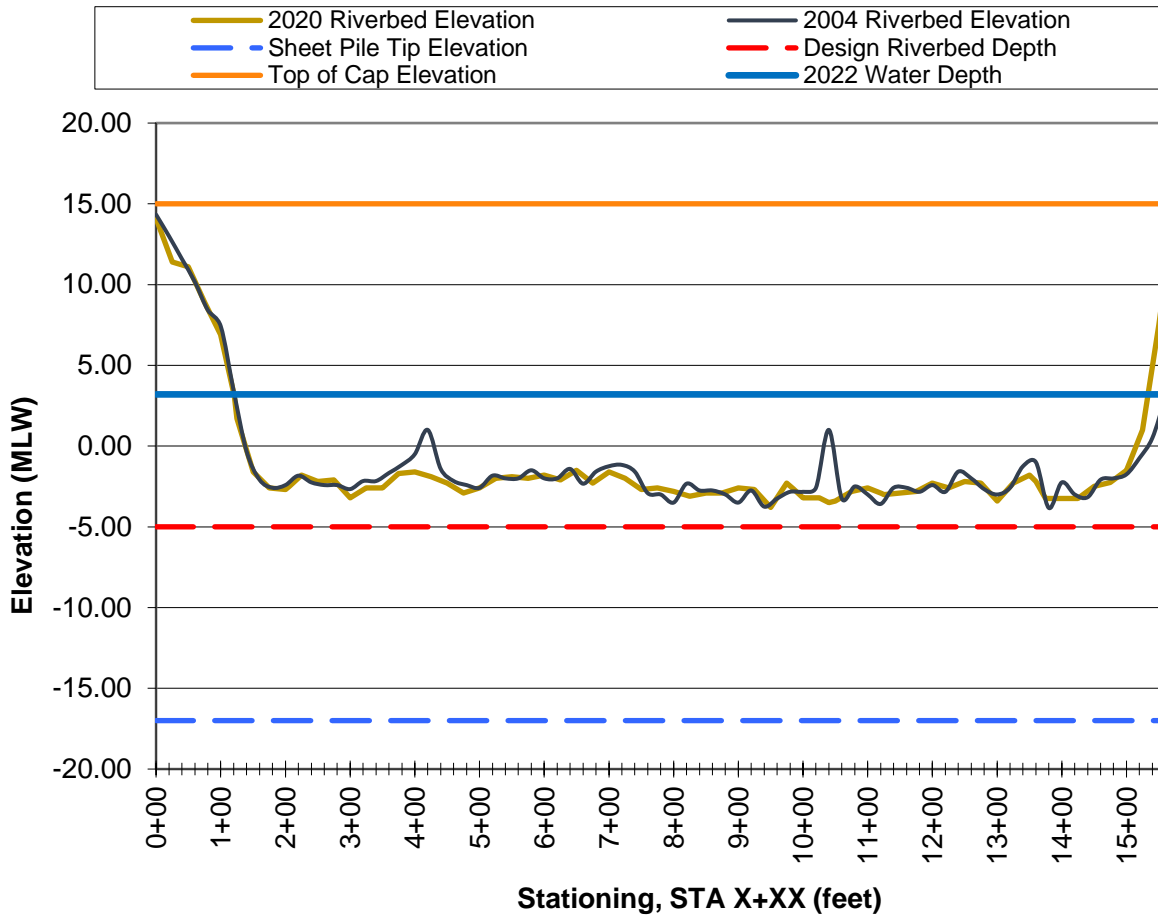
The riverbed elevation varies along the length of the steel sheet pile bulkhead. Graph 2.2 below shows the existing riverbed elevations, design riverbed depths, and sheet pile tip elevations, based on soundings performed during the site inspection in 2022 and 2004. Per this graph it can be seen that the existing riverbed is above the design depth along the entire length of the bulkhead and there has been minimal change over the previous 18 years.

**GRAPH 2.2: BULKHEAD SOUNDINGS (2022 & 2004)**

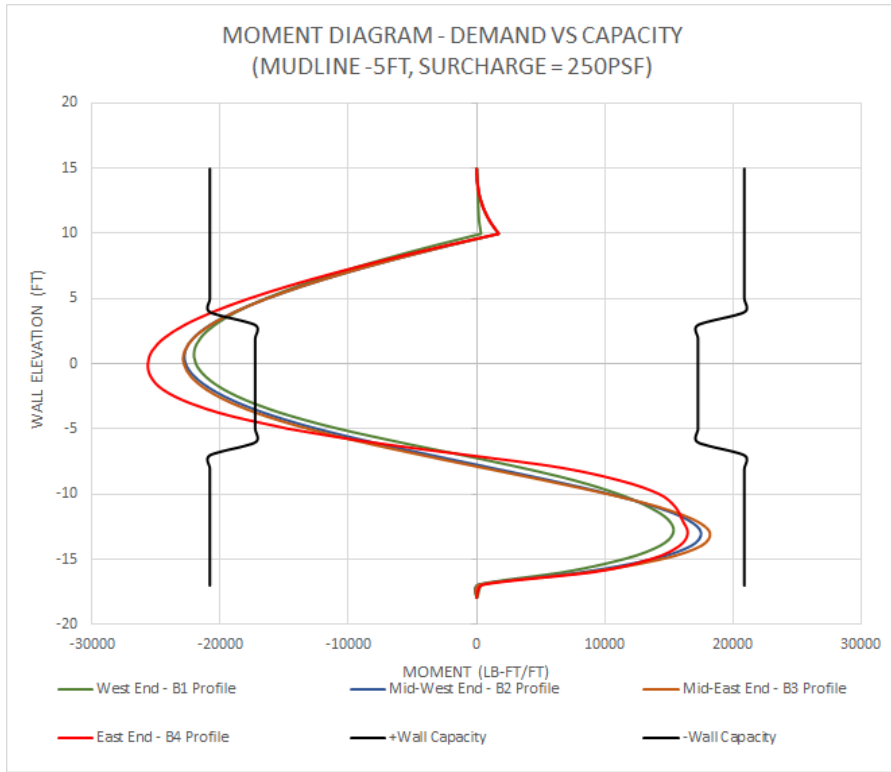
**GRAPH 2.3: BULKHEAD CAPACITY AND DEMAND WITH 250 PSF SURCHARGE (LIGHT VEHICULAR LOADING)**

The bulkhead analysis was performed based on standard engineering practice and available geotechnical parameters. As shown, the analysis indicates that the steel sheet piles are significantly overstressed under typical pedestrian and vehicular loadings. The actual field conditions do not show signs of overstress such as excessive deflections indicating failure. However, it is not possible to state, based on engineering practice, that the bulkhead in its current condition is safe. Continued inspection and monitoring of the bulkhead are required in addition to structural repairs or replacement.

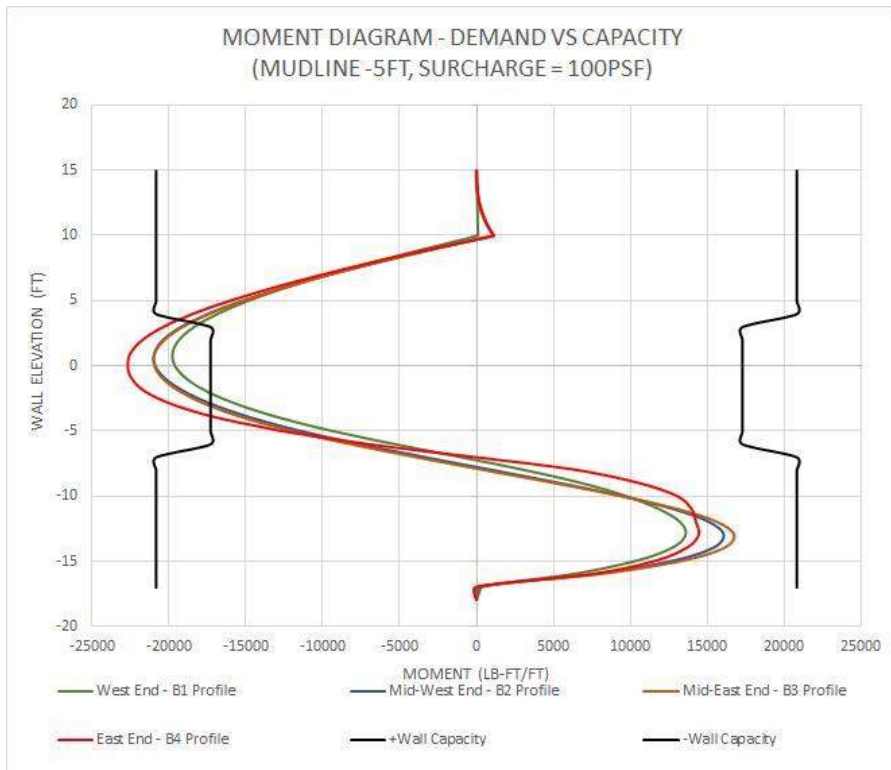
**GRAPH 2.4: BULKHEAD CAPACITY AND DEMAND WITH 100 PSF SURCHARGE (PEDESTRIAN LOADING)**
