City of Greenville, North Carolina

Historic District and Local Landmark Design Guidelines

Adopted March 25, 2014

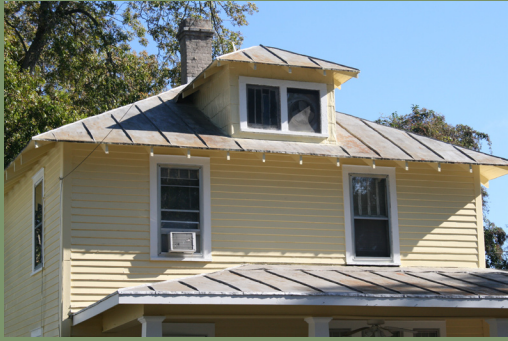
An example of a standing seam roof in the College View Historic District. This home also retains pressed tin shingles on its dormer.

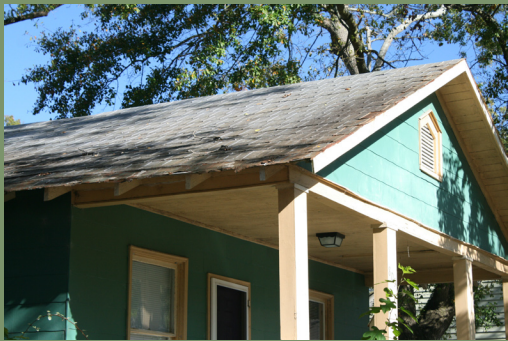
Original pressed tin shingles cover a College View Historic District roof.

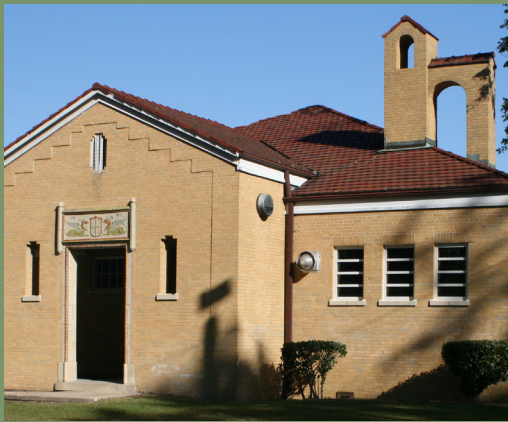
The red clay tile roof of the Third Street School is a defining feature of its Spanish Colonial Revival style.

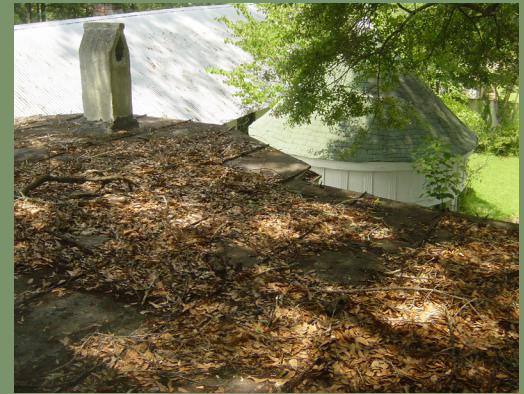
A flat roof covered in organic debris from an adjacent tree. Flat roofs are especially prone to the accumulation of organic material which holds moisture against the roofing and leads to its degradation. A push broom should be used to clear roofs of plant debris. Trees should also be pruned to keep branches off of direct contact with the roof or other parts of the house.

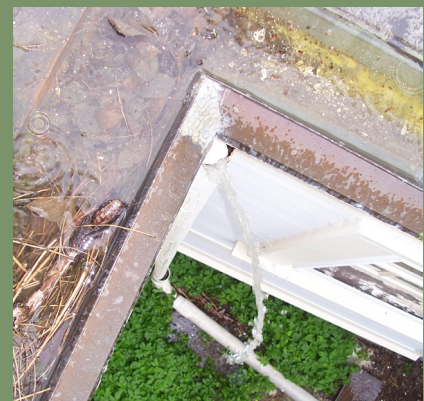
During a rainstorm, a gutter's failed connections show themselves. Take the opportunity to inspect roofs and gutters when its raining.

Rainstorms are also a good time to take a walk about your building and observe the function of gutters. Properly functioning gutters should direct the water away from the roof and the sides or the building without leaving it pooling around the foundation. If gutters are overflowing, clean them and check for blockages on the next dry day. If water is pooling around the foundation, the ground may be eroded and inappropriately sloping towards the building. If this is the case, consider regarding. A quick and easy solution to get water directed away from the building is the installation of plastic flexible drains at the end of the gutters. These may be buried or left at grade level. If left above ground, they should be discreetly screened with landscaping.

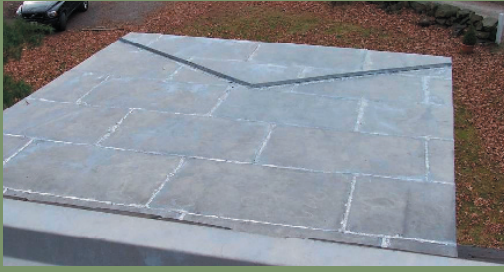
Example of an acceptable modification to a historic roof design. The new V-channel on this dormer roof will protect the face of the dormer from excess rain runoff, but is completely invisible from the ground.

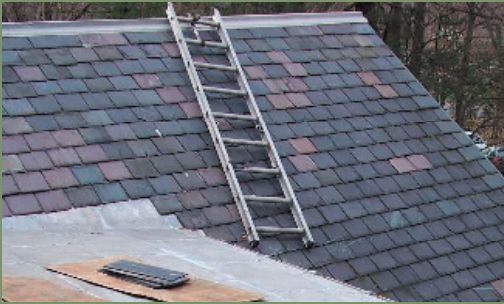
A roof restoration nears completion. Note that replacement slate appear lighter than other slate. They are in fact the same color as the unexposed portions of the older slate and will age to the same color. This is the correct approach. Replacement and repair materials should never be falsely aged or darkened to match weathered materials.

Periodic inspection of the roof, as well as the underside of the sheathing should be conducted to check the condition of the roof and the existence of leaks. Heavy rainstorms are good opportunities to inspect the attic for leaks! If a leak is discovered, a repair should be made as soon as possible. Repairs should always be executed with materials visually and physically compatible with the existing roof. Too often uninformed use of improper materials leads to more extensive roofing issues. If in doubt or the appropriate repair material and method, consult a professional. Particular care must be taken with tile and slate roofs. Accessing and replacing a broken tile or slate without damaging others requires experience and skill.

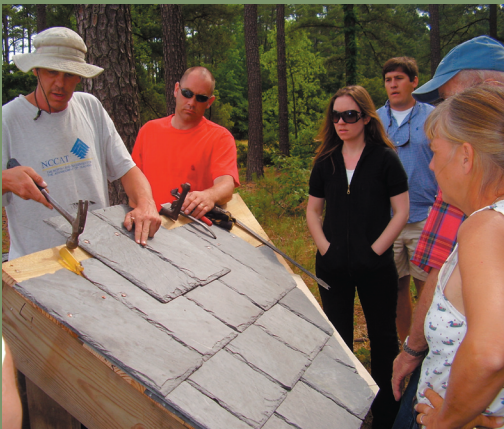
Attendees at an Edgecombe Community College, Preservation Trades Program, Preservation Trades Day learn about slate roof repair. The Preservation Trades Program is an excellent resource for property owners who want to learn how to work with historic materials. Photograph courtesy Monika Fleming, Program Coordinator, Historic Preservation, Edgecombe Community College.

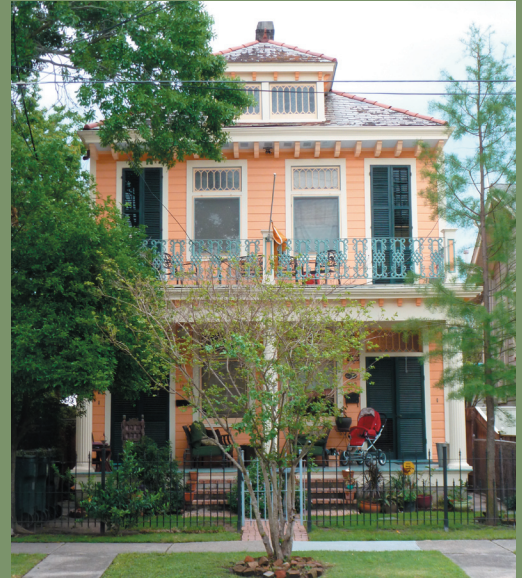
The character defining front roof slope of the above house retains its original appearance, while solar panels are appropriately installed on a secondary slope. Photographs courtesy Heather Knight.

12. Solar panels should be mounted as flush as possible on a side or rear roof slope hidden from view of the public way. They **must** be installed in a manner that is as discrete as possible and does not damage historic fabric.

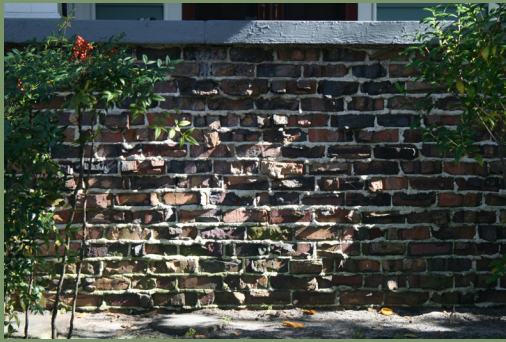
Skintled brickwork is one of the distinctive exterior wall materials found in the College View Historic District.

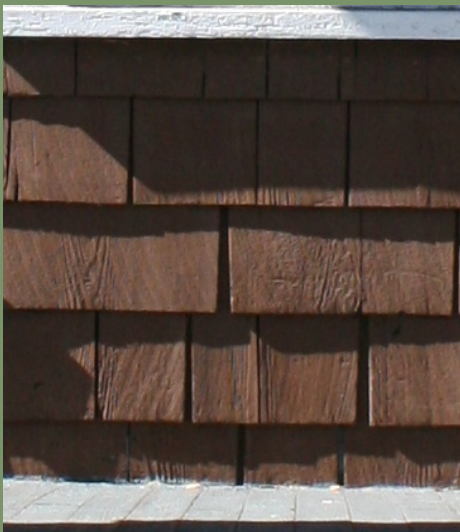
Sunlight highlights the textural character of wood shingles on a bungalow in the College View Historic District.

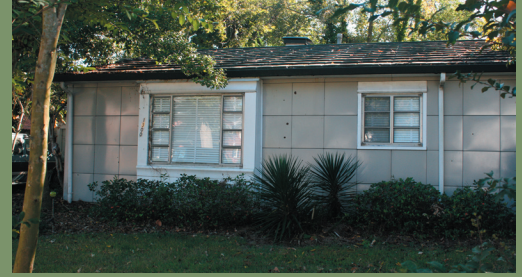
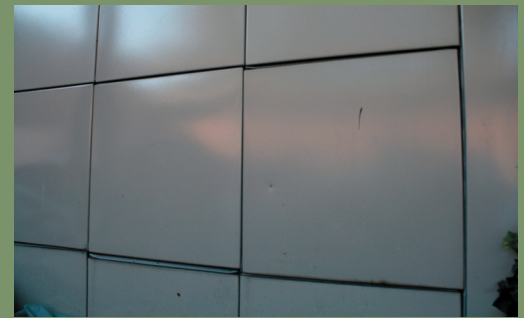
The porcelain-enameled-steel panels as seen above are a defining element of the iconic Lustron house.

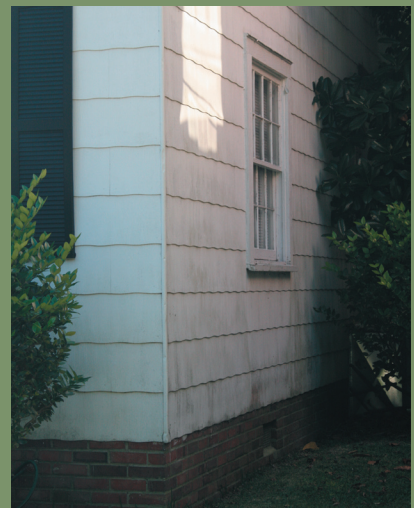
Promoted for their fire resistance, asbestos shingles were one of the early kinds of synthetic siding. Several houses in the CVHD retain their original asbestos shingles.

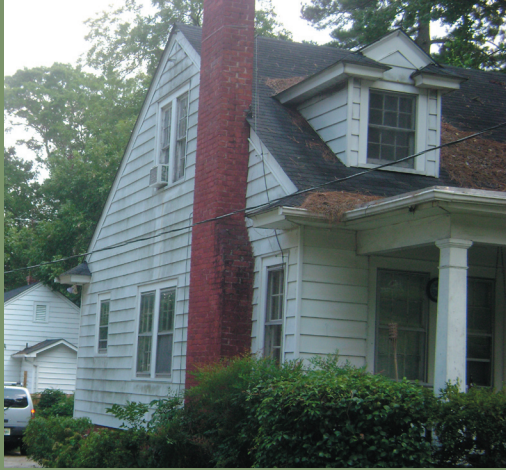
House covered in aluminum siding before project.

With financing from the Preservation Pilot Loan Program, the exterior of this home was beautifully restored. Work included the removal of aluminum siding and the scraping and painting of the wood weatherboards. The work also qualifies for North Carolina Historic Preservation Tax Credits.

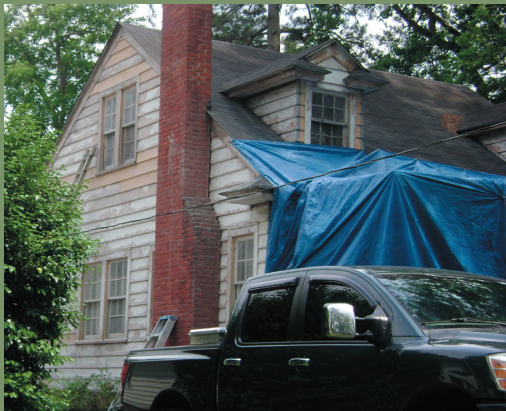
Original weatherboards are scraped and prepped for painting during restoration.

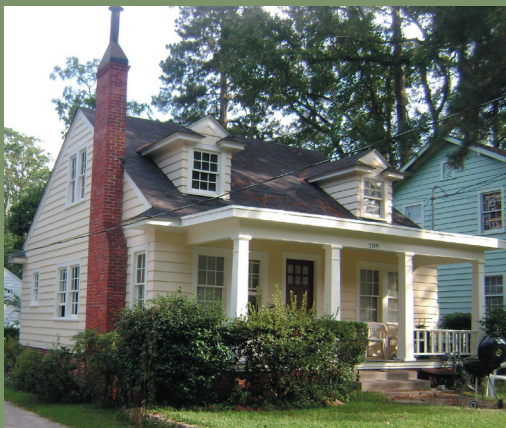
Original materials glow in the sunlight after the completion of restoration work

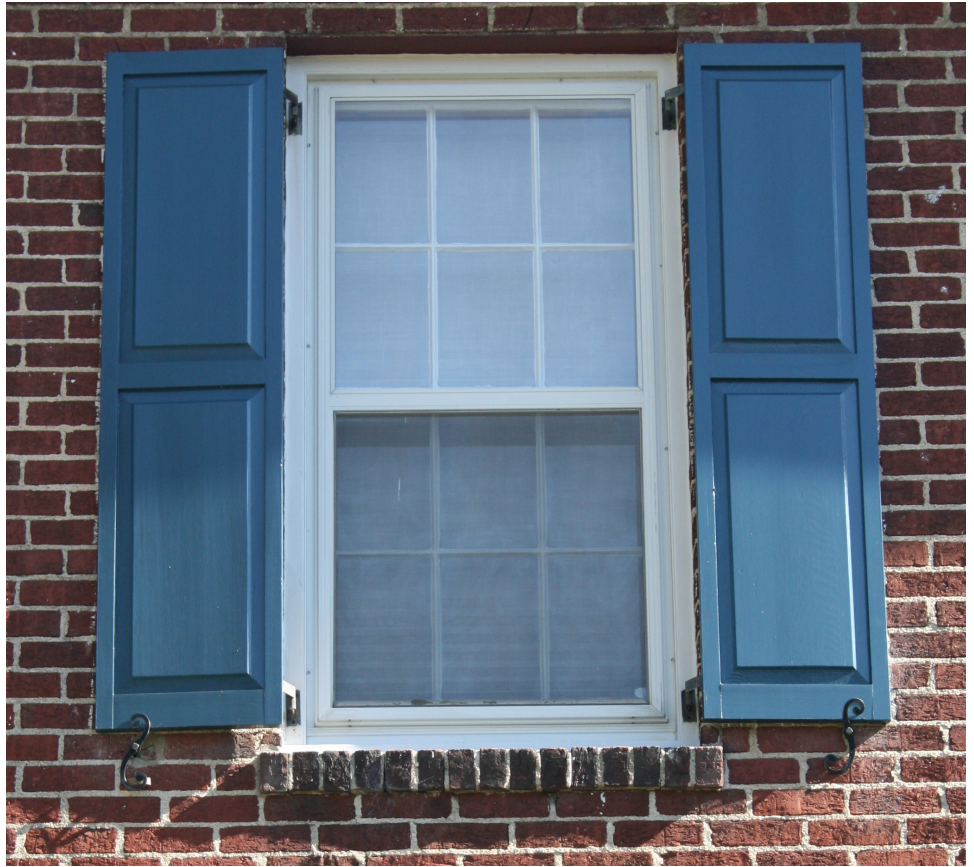
On the previous page: A window that has it all! This well-maintained Colonial Revival window has its wooden shutter properly hanging on hinges and secured open with shutter dogs. A triple track storm and screen window protects the wooden sash, increases the R-value of the window unit, and enhances its ventilation function. Despite its deep profile, the triple track storm window is barely visible because it is properly aligned with the meeting rails of the window sash and is the same color as the sash and trim.

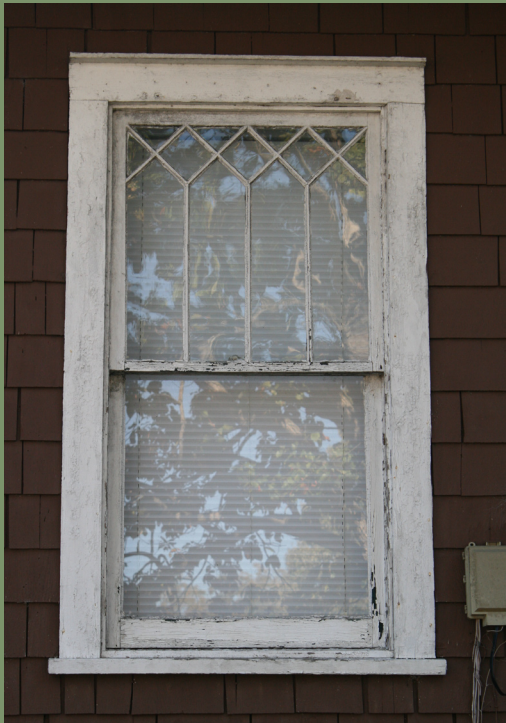
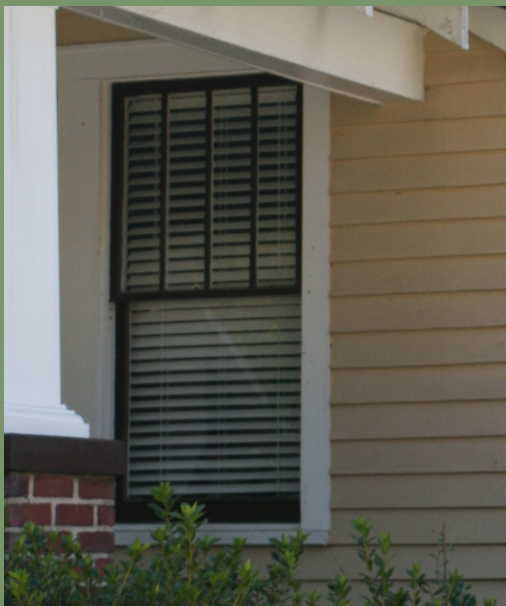
Typical bungalow windows in the CVHD.

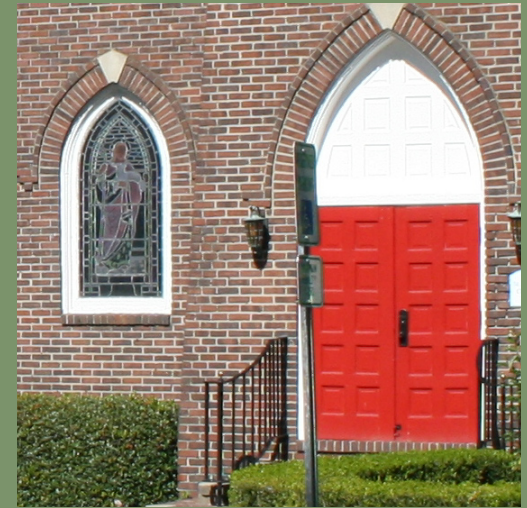
Lancet arched doorway and window with stained glass at St. Paul’s Episcopal Church.

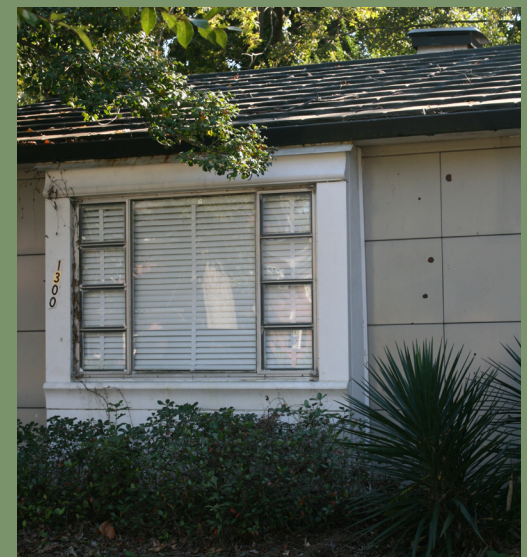
Aluminum casement windows in the Lustron house.

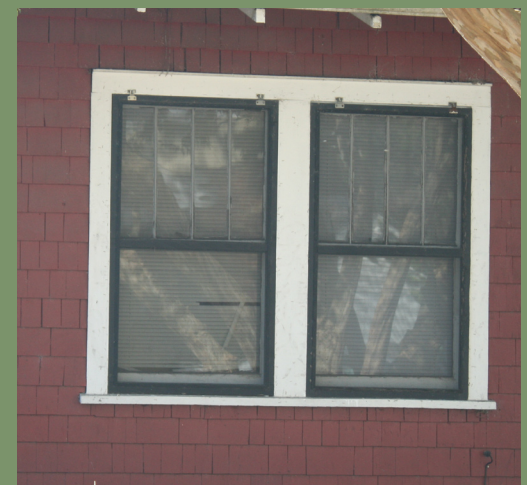
Early twentieth-century screens on a College View Historic District home.

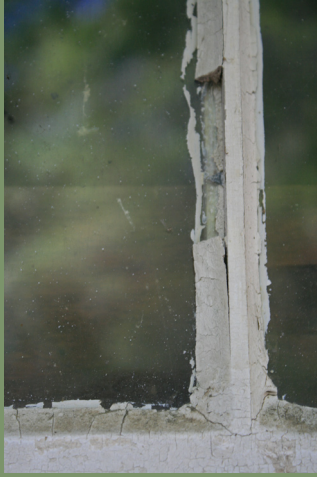
A missing piece of glazing is an indication that a window pane needs to be reglazed. Glazing should not be patched; one whole stretch should be completed at once for proper seal and bond. But it is not necessary to do more glazing than required at one time. Panes may be treated individually, if the glazing of other panes is truly sound, though often this will not be the case.

Glazing also requires periodic maintenance. When the glazing putty that seals the glass panes within the wooden sash dries and crack apart, panes may loosen and air may escape or enter. Failed glazing putty should be carefully removed and new putty properly applied. See resources – particularly Preservation Brief 9, Leeke, New York Landmarks Conservancy, and Edgecombe Community College – for further information on reglazing windows. If window panes are broken, they may be easily replaced by removing glazing points and inserting a new piece of glass.

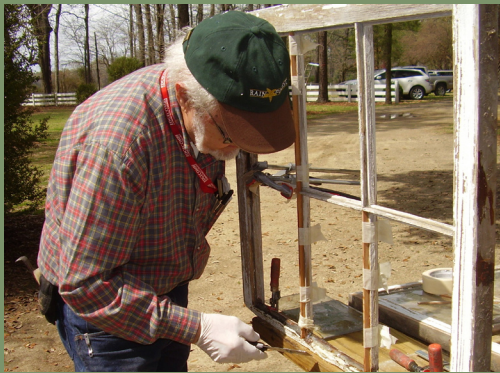
A student works on a complicated muntin repair at an Edgecombe Community College Preservation Trades Workshop. Even severely deteriorated window sash can typically be restored and the result is far superior to a contemporary “replacement” window. Photograph courtesy Monika Fleming.

When paint and glazing are not maintained, wooden elements of windows and doors may rot. If this occurs, repair or replacement of only the damaged portion of the frame, the sash, the sill, or the threshold will eliminate the problem. A carpenter trained in preservation techniques can cut out the deteriorated section and fit in a new piece of wood that matches the dimensions and profile of the rest of the element exactly. This is called a Dutchman repair. Alternatively, deteriorated wood may be able to be filled with a wood consolidant and epoxy. A number of two-part wood consolidant epoxy systems on the market can restore a section of rotten or damaged wood. The guidelines for wood provide more information on wood repair.

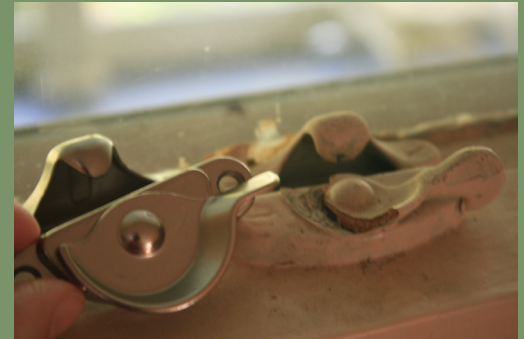
An easily undervalued part of the thermal performance of windows is their hardware. Windows - old or new - must be able to stay closed to prevent air infiltration and window locks assure this. If the window locks of historic sash have broken, they are typically easily replaced. Here, a new lock from a local hardware store is ready to replace the broken one seen at right.

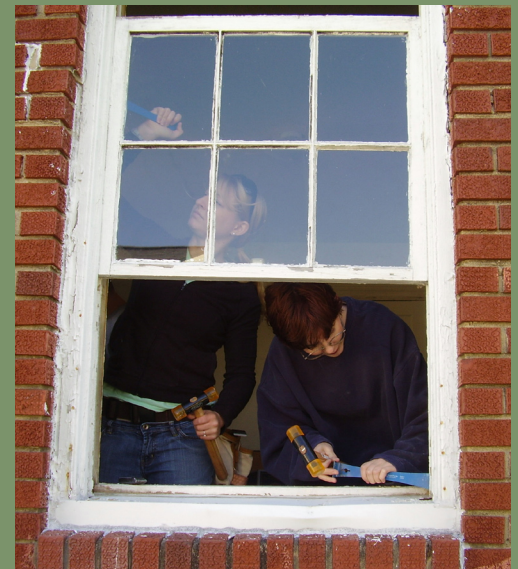
Students of the Edgecombe Community College Preservation Trades Program remove a window sash from its casing. When sash require extensive work, as in Dutchman repair and reglazing or stripping, it is best to remove the sash and complete work on a bench. Simple maintenance can be done in situ. Photograph courtesy Monika Fleming.

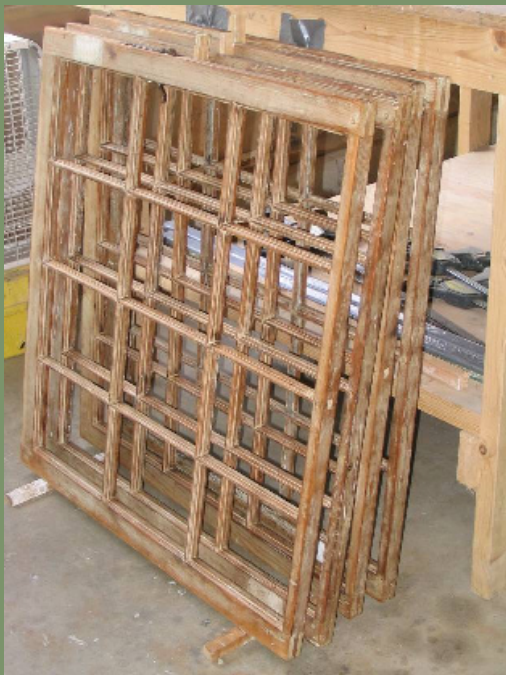
Window sash stripped of their paint by use of steam sit ready for replacement of their glass. It is not always necessary to strip a window for restoration work, but if extensive wood repairs are necessary or lead abatement is desired, steam is a good method for paint removal.

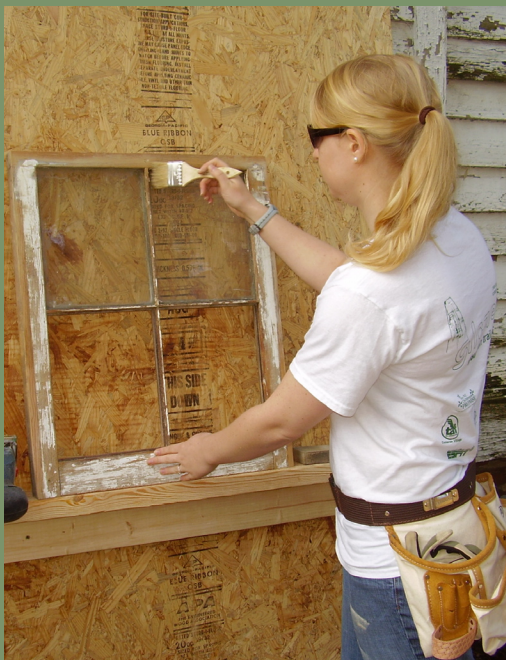
A student in the Edgewcombe Community College Preservation Trades Program primes a window sash during the restoration process. Photograph courtesy Monika Fleming.

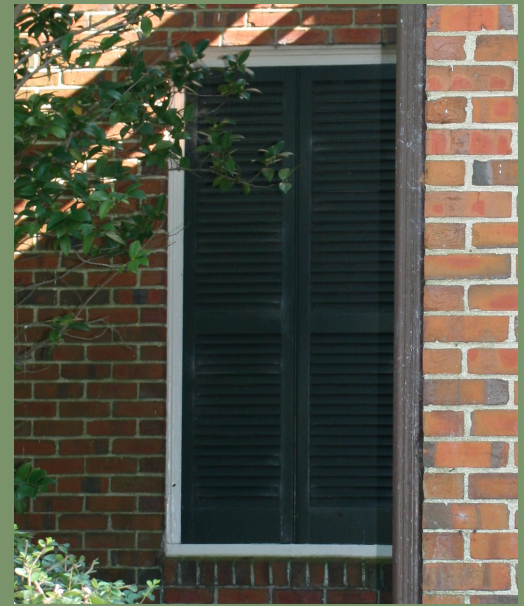
Closed shutters effectively block out solar radiation while louvers can still allow ventilation.

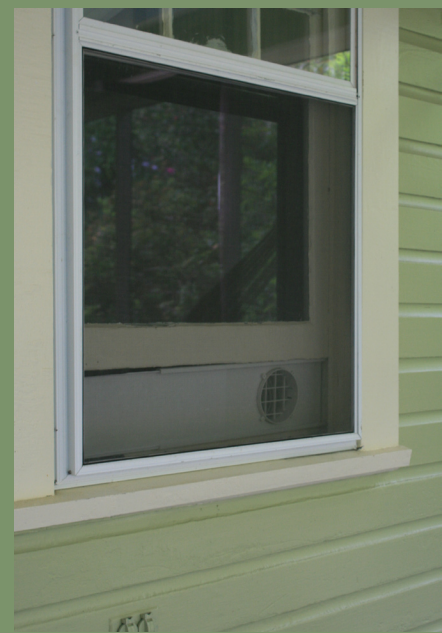
The vent of a portable air conditioning unit is far less obtrusive and less damaging to the window fabric than a window unit.

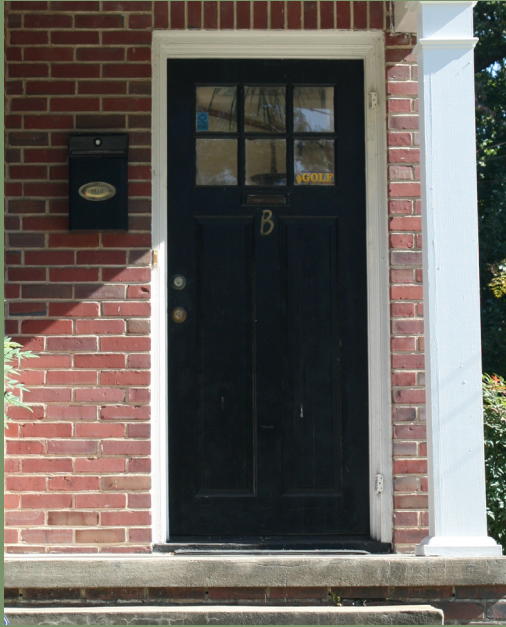
Above, a well preserved example of a style of door that appears on many College View Historic District homes. Below, the same style of door is fitted with a storm door that appropriately allows most of the door to be seen.

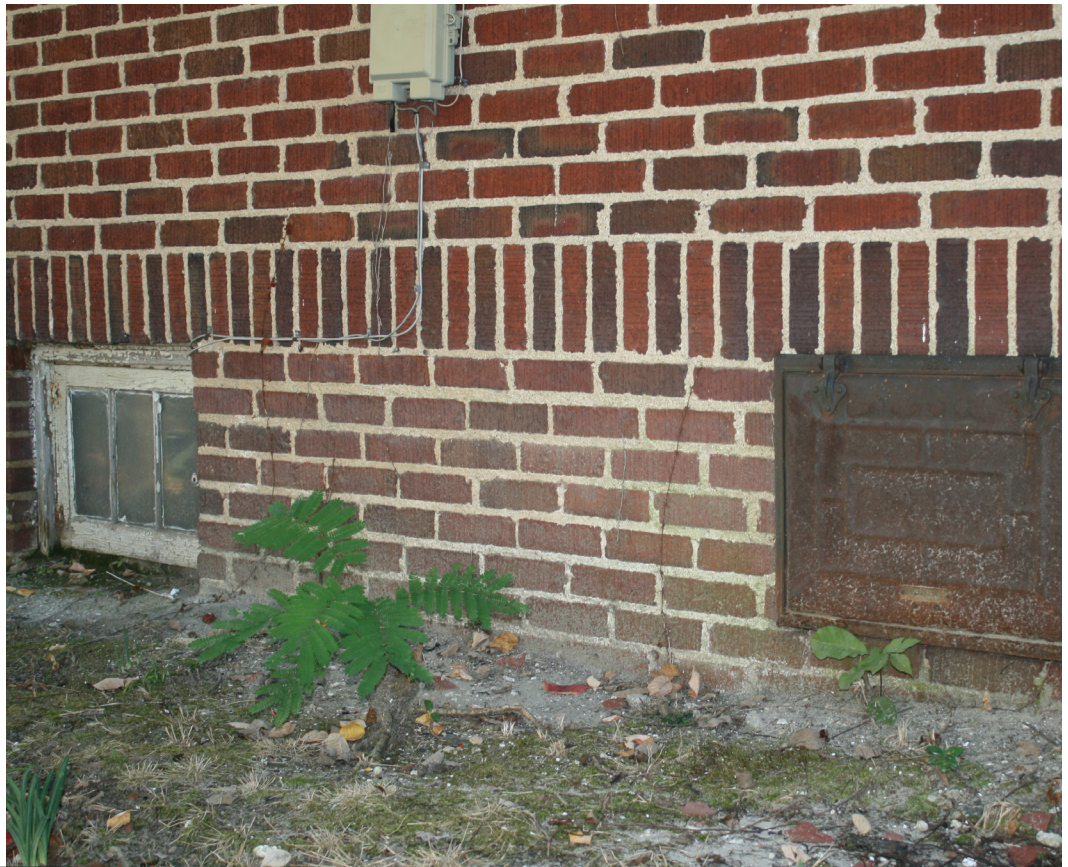
Preceding page: Historic elements of this foundation in the College View Historic District include a historic window and a coal door. It also displays a decorative band of upright bricks (a soldier course) referred to as a water table.

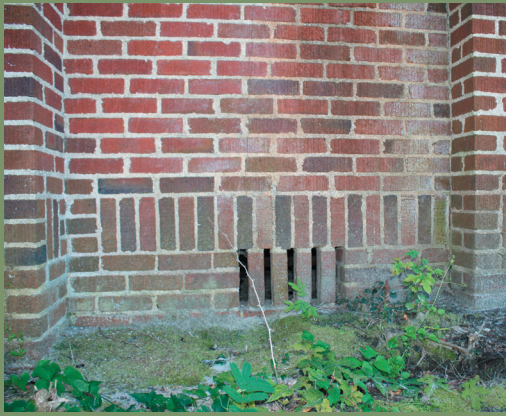
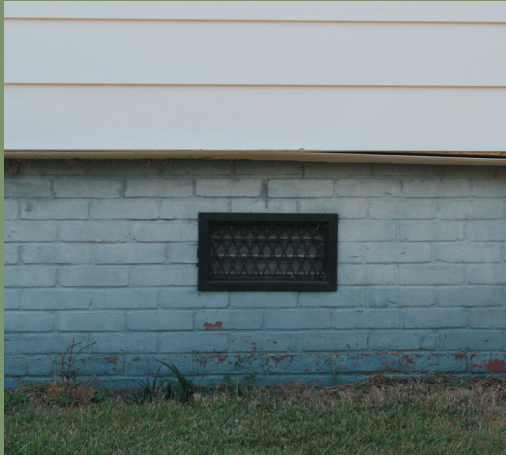
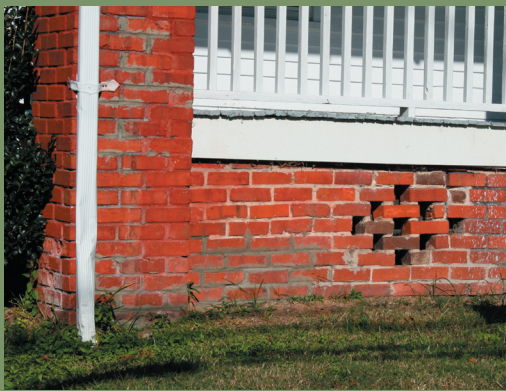
Three examples of foundation ventilation found in the College View Historic District. Two styles of pierced brickwork and a modern louvered ventilator. Foundation ventilation is an important part of limiting moisture collection beneath a house.

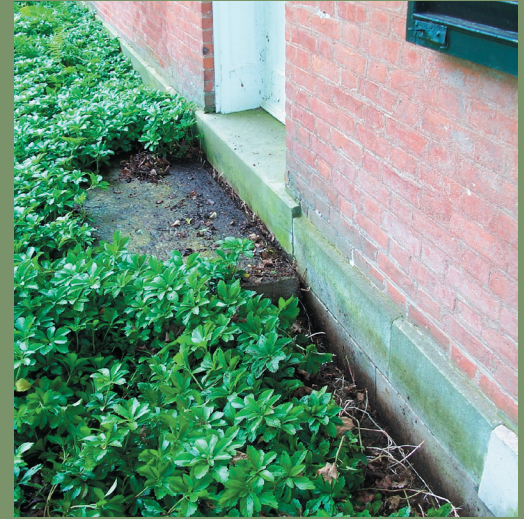
Vegetation should be kept off of foundations. At the above property, pachysandra was allowed to grow against the foundation, contributing to moisture issues. On the right, the vegetation has been cut back, revealing the line of biological growth that thrived on the granite in the moist environment.

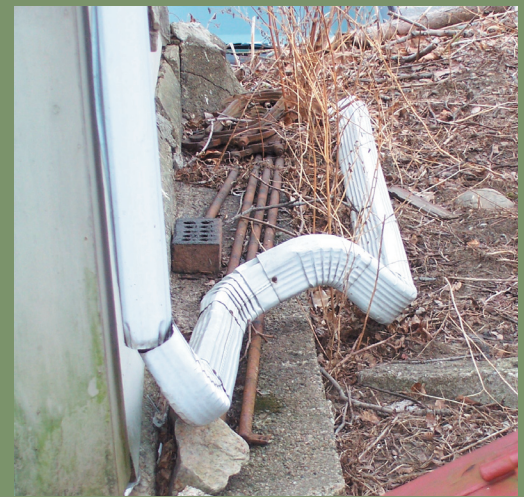
Good gutter design and maintenance is essential to avoiding foundation problems. Here, a poor attempt to repair a gutter leaves water funneling directly against the foundation.

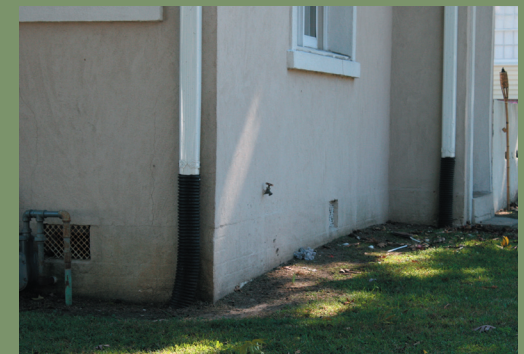
Flexible drains buried in the ground is one effective way to channel water away from a foundation.

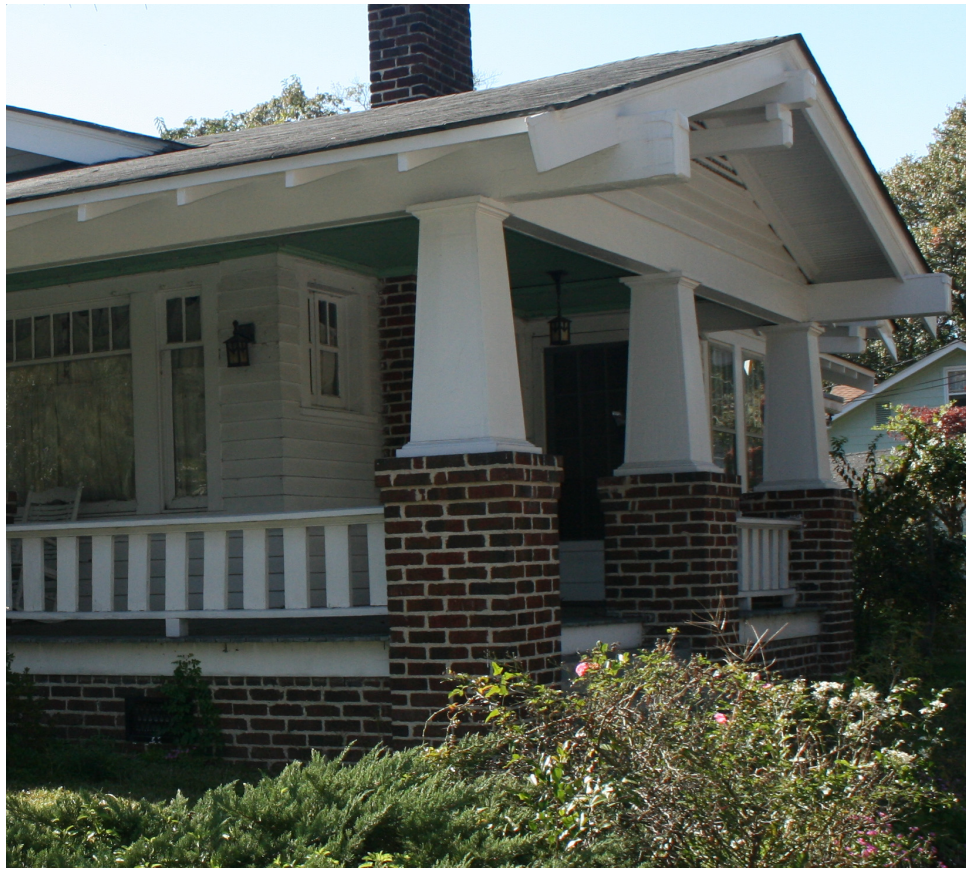
Preceding page: An ample porch extends living space outside and provides a solar break for the interior. Tapered, boxed wood columns on brick bases are a typical bungalow porch feature.

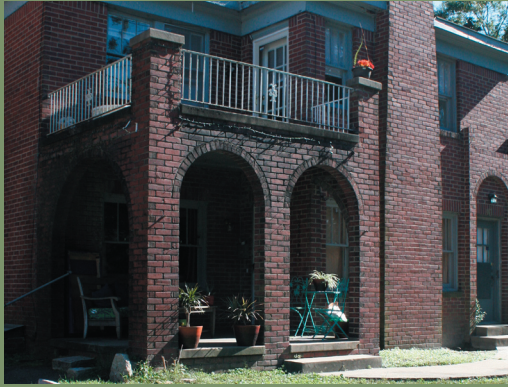
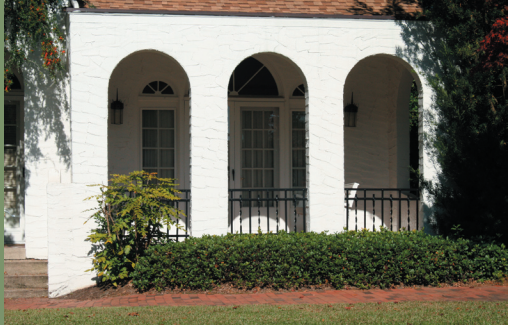
Although most of Greenville’s local landmark and historic district porches are primarily wood, some like the two above examples also feature brickwork, stucco and ironwork.

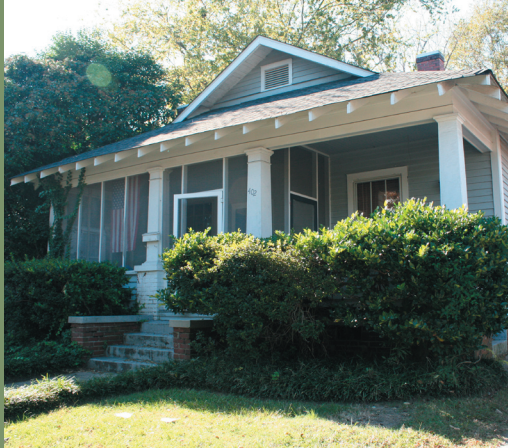
This partially screened porches offers a good example of historically appropriate porch screening. Here, slender wooden uprights support the screening between the boxed columns, which remain prominent and character defining.

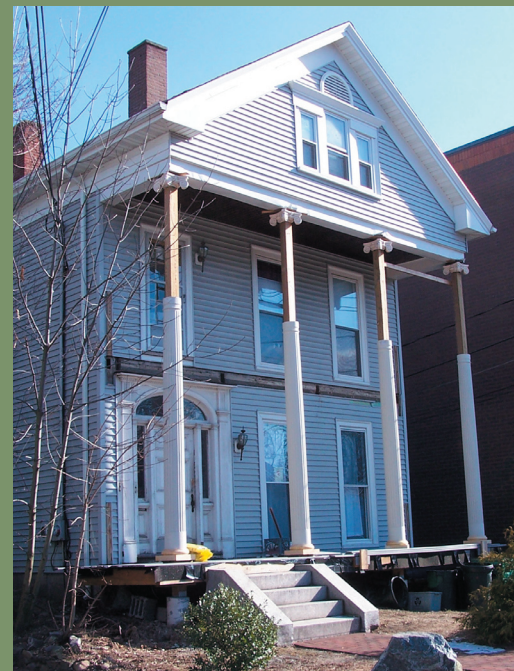
These precast columns demonstrate just how bad the results can be when imitation features literally fall short of original historic fabric. When replacement of an element is necessary, it must always match the original as closely as possible. Custom work is most often the best way to accomplish the job correctly and with durable materials.

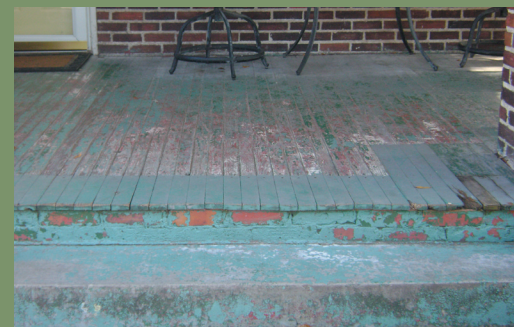
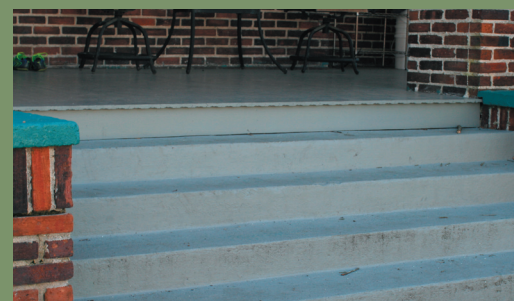
The deteriorated portion of the above porch floor was properly repaired and repainted as part of a COA project.

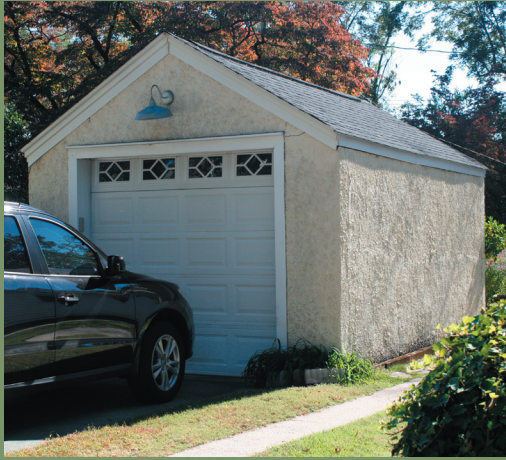
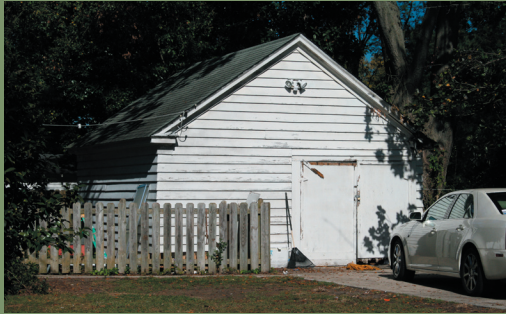
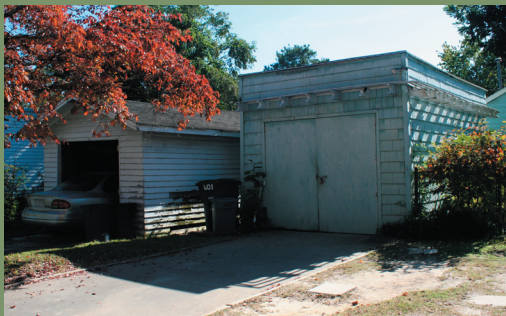
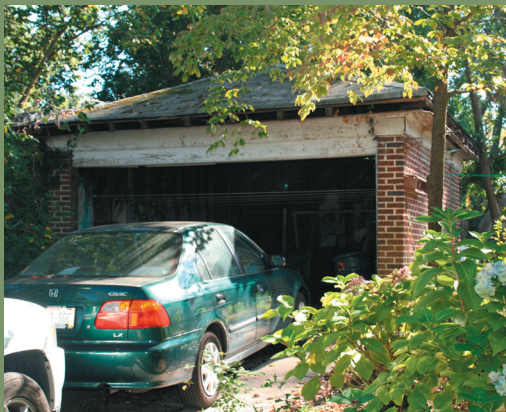
Above and on preceding page: Like the houses of the College View Historic District, the garages display a variety of styles and materials.

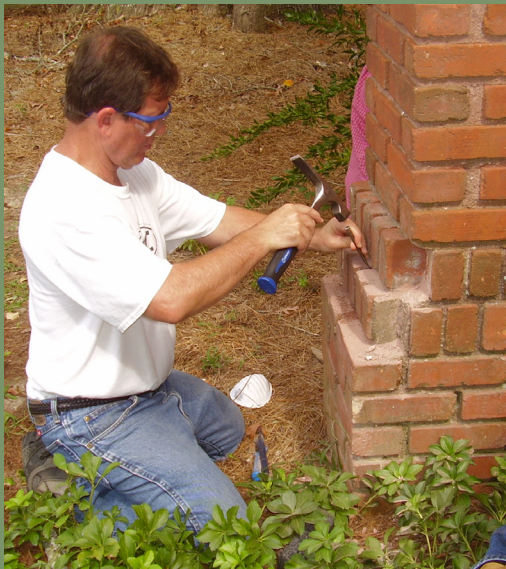
A Preservation Trades student of Edgecombe Community College cleans a joint in preparation for repointing. Note that eye protection should always be worn when doing this work. Photograph courtesy Monika Fleming.

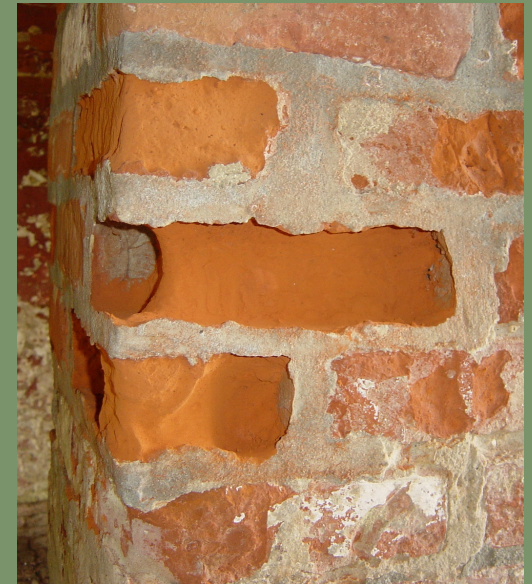
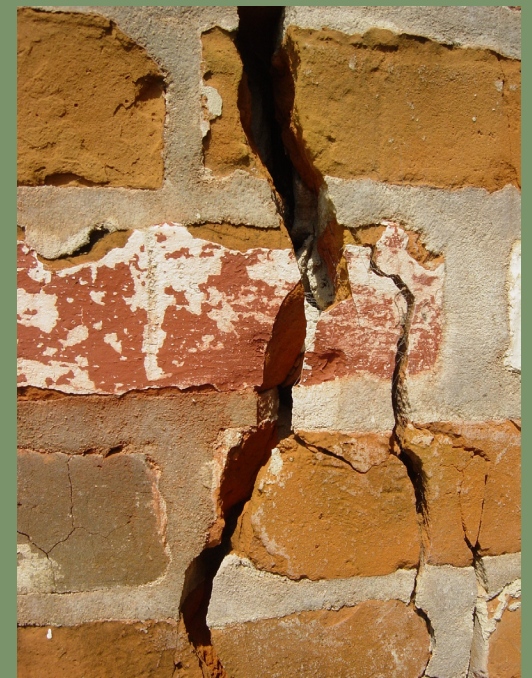
Two extreme examples of what excessively strong and impermeable mortar can do to softer brick. In the top photograph, moisture that was wicked up from the ground through this pier was forced to migrate through the brick because of the inadequate vapor permeability of the new mortar. The concentration of moisture in the bricks eventually eroded some completely, leaving a skeleton of mortar. The bottom image shows a dramatic crack that resulted from a stress of the pier. If the mortar had been appropriately weaker than the brick, the crack would have carried through the joints leaving the bricks unharmed, but the excessively strong mortar forced the stress through the bricks.

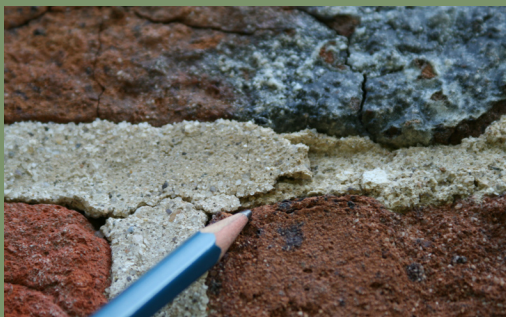
A close-up photograph of defective repointing indicating the edge of the newer mortar and the original mortar exposed to the right.

The above diagram depicts the differences between a defective repointing job and a proper one. The defective job leaves excess mortar on the face of the masonry units which is unattractive and makes an area of repointing obvious. It also traps water which can cause further damage to the masonry and will eventually cause the repointing to fail.

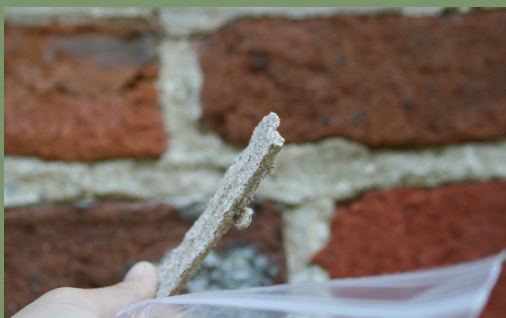
A piece of failed repointing mortar is held up to show how thinly it was applied.

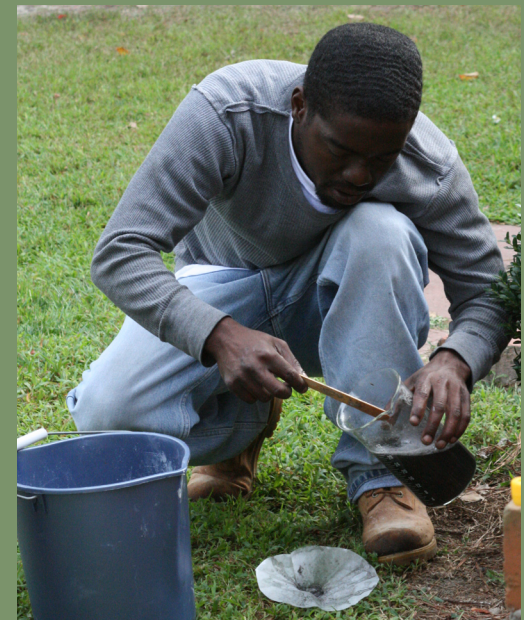
A mason demonstrates a quick field characterization of a mortar sample for Edgecombe Community College Preservation Trades students. By dissolving the binder of the mortar, the aggregate particle size, distribution and color can be examined as well as any additives that remain.

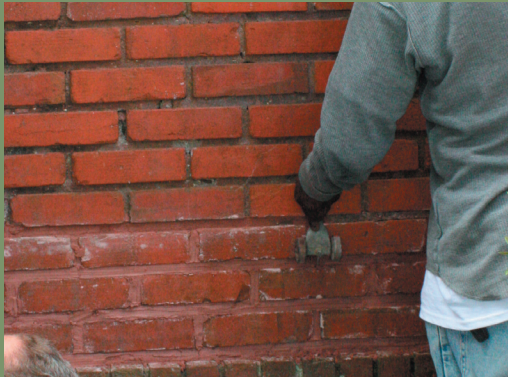
Raking the repointed joints of the above project with a skate.

Edgecombe Community College Preservation Trades students repoint an exterior wall. For this application, the mortar was tinted with masonry pigments to match the original early-twentieth century tinted mortar and the joints were raked to match the profile and depth of the original.

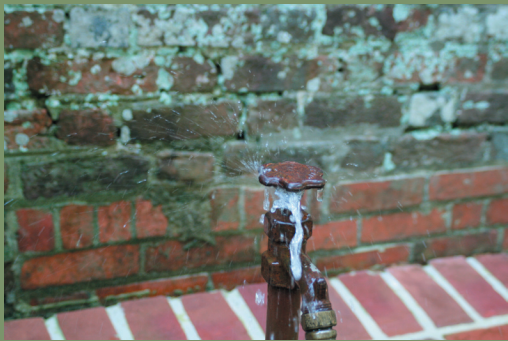
To avoid having to repoint masonry, keep it dry! In the above photograph, a leaky faucet has been routinely spraying the historic masonry wall behind it every time the sprinkler system goes off. As a result, lichen is thriving on the wall and the bricks and mortar deteriorated. A bad repair was then made with completely incompatible modern bricks and mortar, but the primary cause of the problem remains unaddressed.

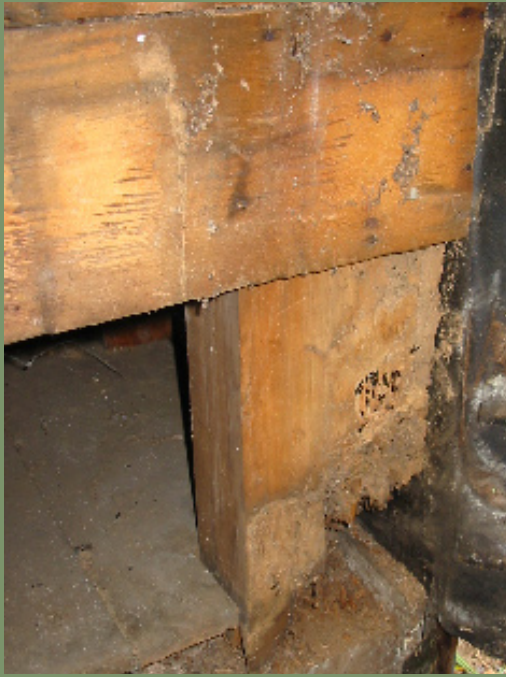
The bottom end of a corner post mostly lost to rot.

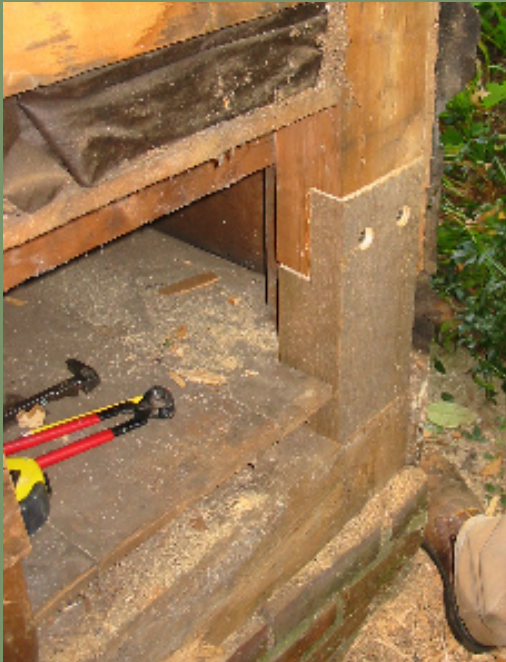
A large scale Dutchman repair secured with a lap joint and bolts. Smaller Dutchman repairs are typically held by their tight fit and glue, with no fasteners.

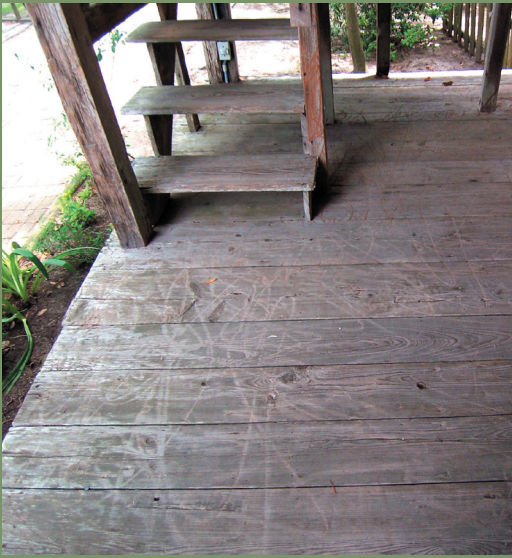
Pressure washer damage is evident on this wood porch floor.

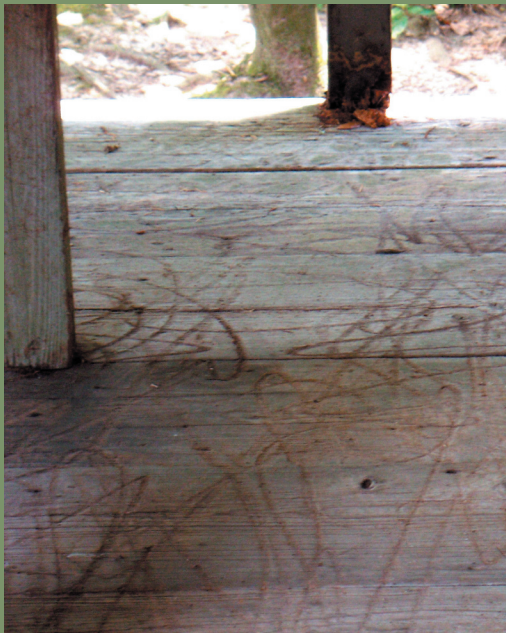
Close-up of pressure washer damage.

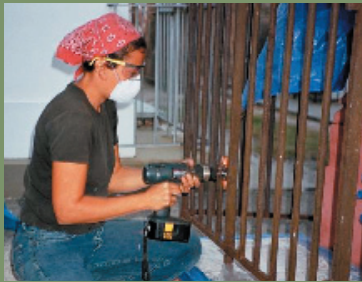
Prepping ironwork for painting with a wire brush drill attachment.

Wire brushing and hand scraping are appropriate techniques for cleaning hard metals, such as steel and cast and wrought iron. A more abrasive technique, such as low-pressure dry grit blasting, should be used only if gentler techniques are unsuccessful and if a test area reveals no damage to the metal surface. Surrounding surfaces should always be well protected with a hard barrier like metal sheeting before use of any dry grit blasting.

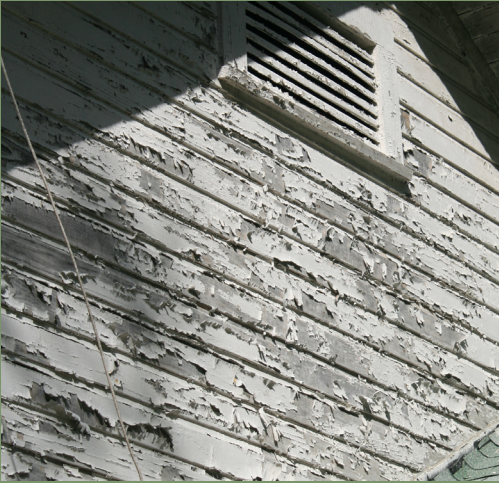
Paint will weather differently on different elevations. Northern facing walls often stay moist and are prone to mildew while the paint on the southern elevation pictured above has suffered from long hours of UV exposure.

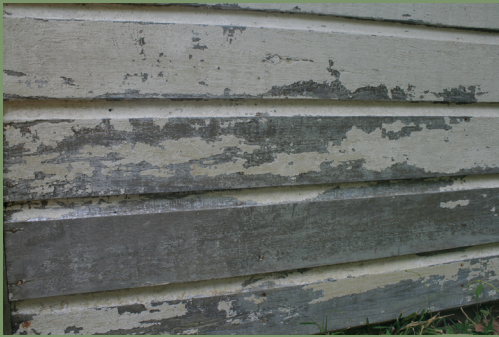
This wall has been scraped and just requires light-sanding and washing to be ready for priming.

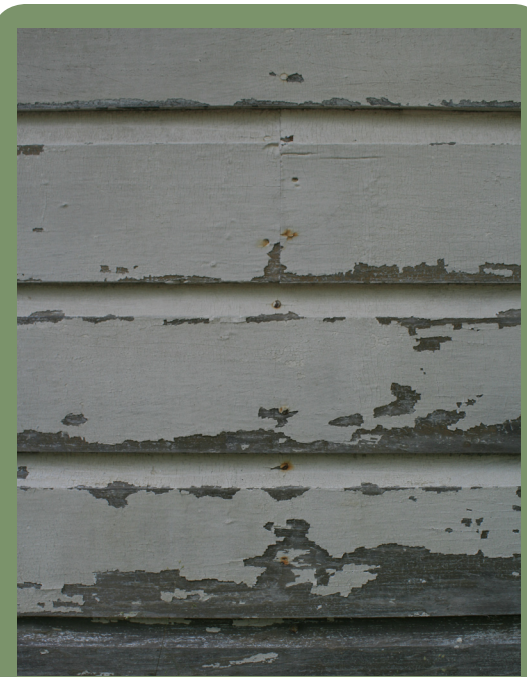
The rust of nail heads will emerge through a new paint job if not pretreated. Touch nail heads with a rust inhibiting priming prior to priming the rest of the wall or element. Avoiding the defacing rust that can appear after the paint job is done is a big payoff for this simple step.

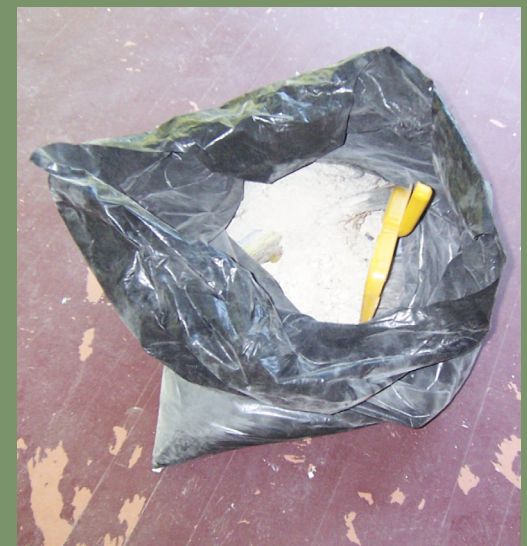
Paint scrapings should always be contained during work and collected and properly disposed of in a heavy trash bag. Bags should be closed by twisting the top, folding it down in a gooseneck, and securing it with duct tape.

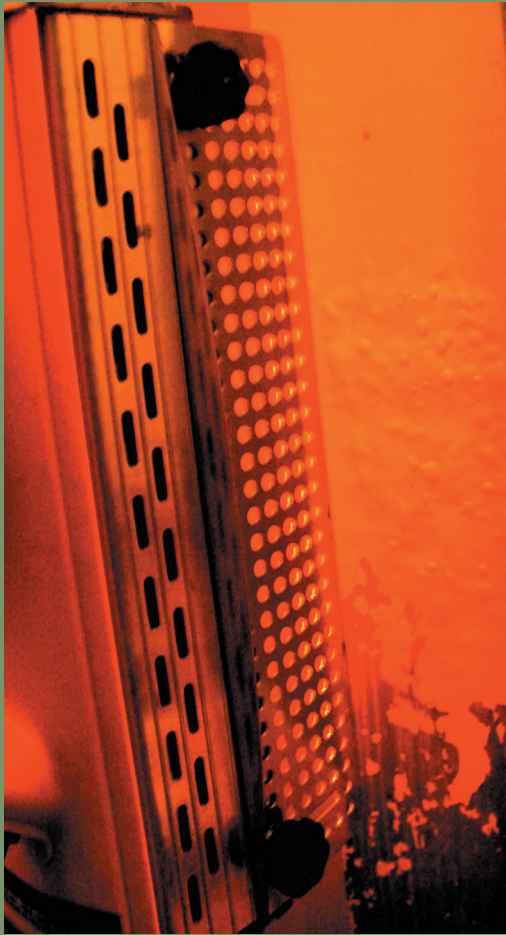
Paint quickly releases from the wood surface and bubbles under the heat of an infrared paint remover.

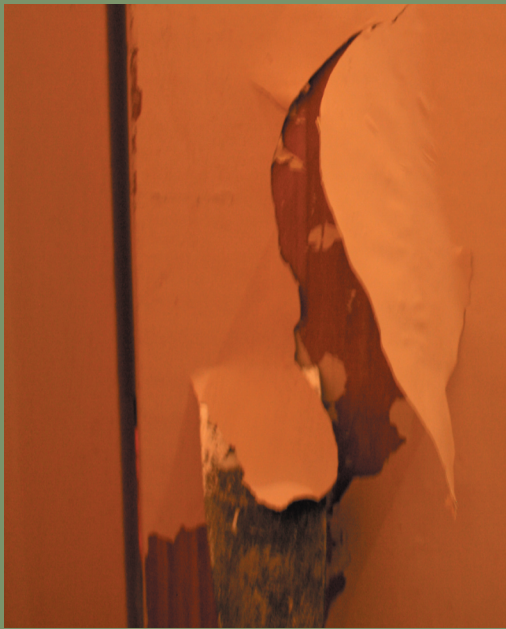
After heating with an infrared paint remover, paint is easily scraped away. This method is especially efficient for removing paint from previously varnished surfaces like doors.
