City of Greenville, North Carolina

Historic District and Local Landmark Design Guidelines

Adopted March 25, 2014

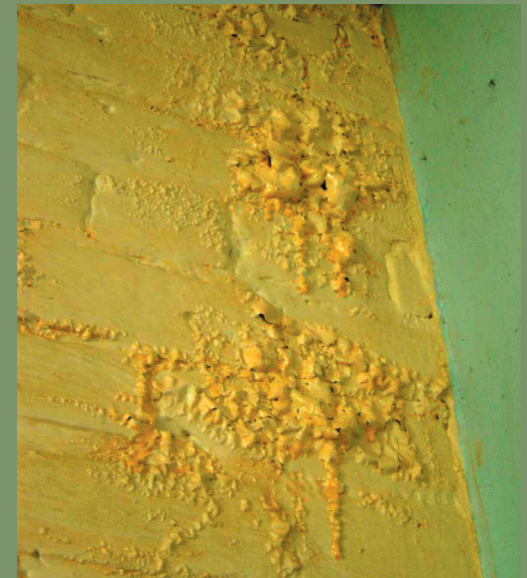
A peroxide-activated stripper at work on a tough old paint coating over brick. This variety of strippers is effective and user friendly. See masonry section.

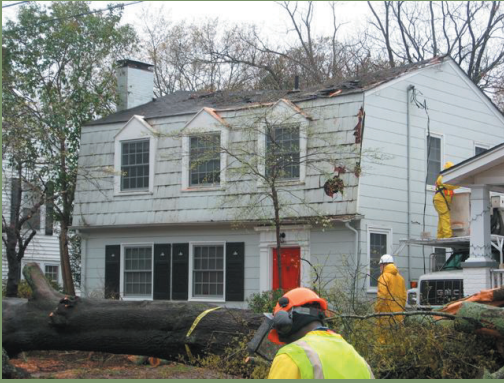
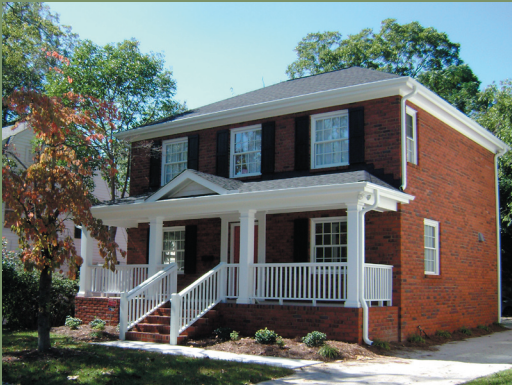
After the above house was irreparably damaged by a fallen tree, this new residence (below) was built in its place. It appropriately draws on the historic scale, proportion, materials and motifs of the district. The original door was smartly salvaged and reused - saving materials and memories.

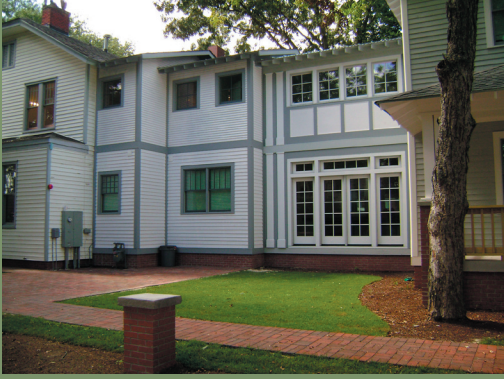
The separation and difference between the original building at left edge and the new building at right edge is clearly articulated by the design of the hyphen between the two. This distinction between old and new construction is important as it helps to honestly present the property's history and avoid a muddling of old and new.

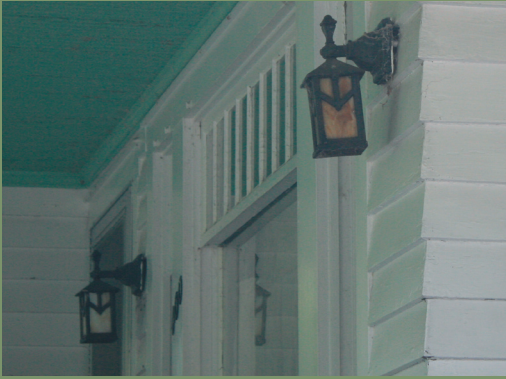
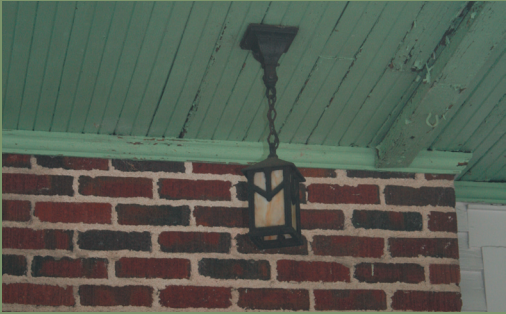
Original Arts and Crafts lighting fixtures (above and below) enhance the porch of a CVHD bungalow.

On the previous page: A soft glow emanates from what is likely an original porch ceiling light fixture. This type of inconspicuous light source is appropriate for the College View Historic District.

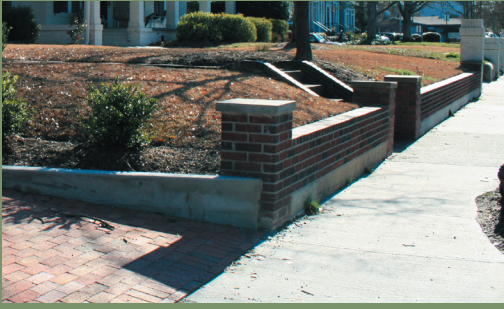
This brick retaining was newly constructed as part of a COA project. Through its proportions, design, and materials it blends in appropriately with the existing streetscape.

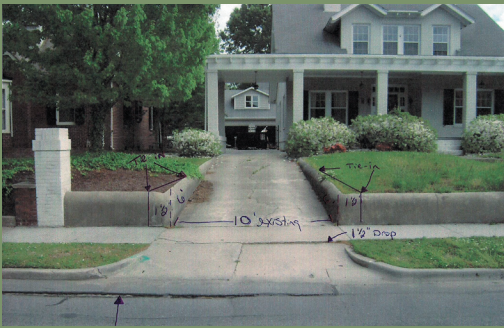
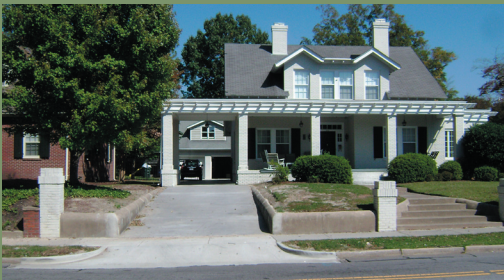
A proposal sketch and after photograph show how a historic concrete retaining wall was successfully preserved while the driveway was widened for improved safety and ease of entry and exit of off busy 5th Street in this COA project.

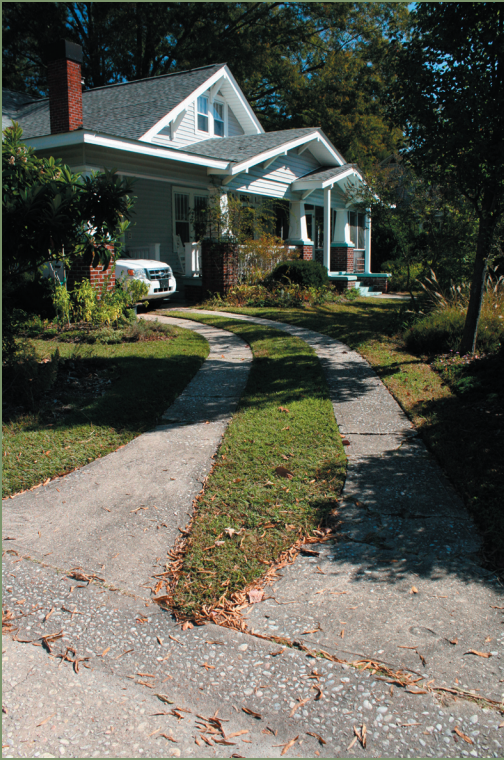
A historic driveway design worthy of emulation. It is not only period appropriate, but its permeability makes it a sound choice for water rainwater management and conservation.

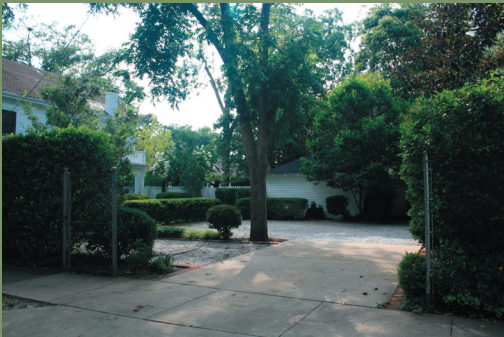
This rear yard parking is appropriately screened from public view, permeable, and incorporates mature preexisting landscaping.

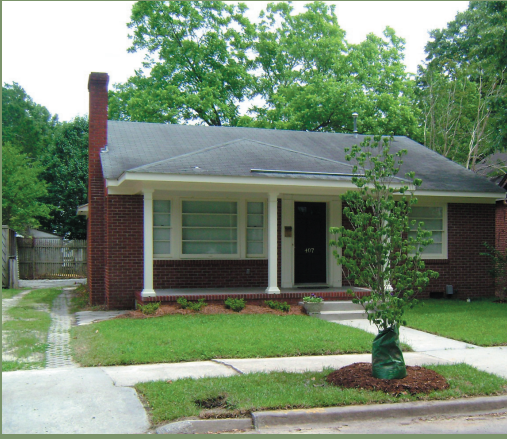
In this COA project, new trees and bushes were planted to replace older specimens that had been removed and a new row of plantings was installed along the property line.

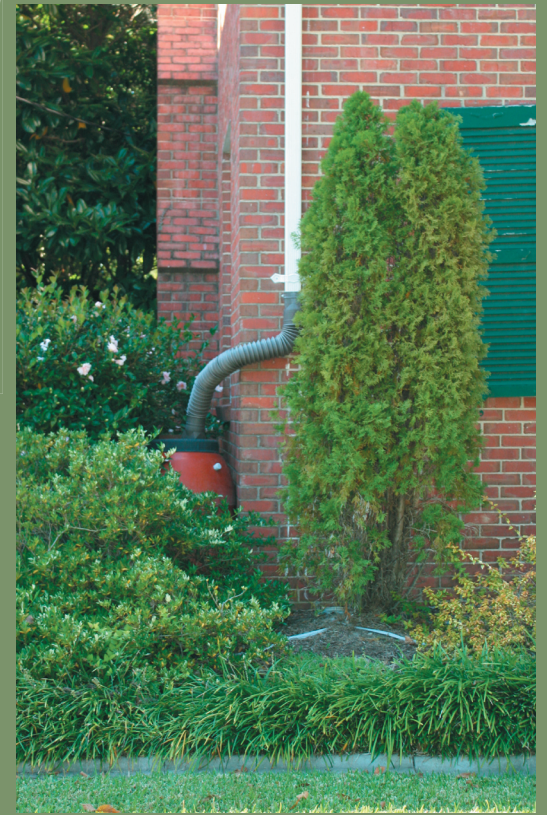
This rain barrel is appropriately placed against the side rather than the front elevation and is discretely screened from public view by plantings. Its color also helps it to blend in with the home's brick exterior.
